PRELIMINARY STUDY ON SNOWPLOW SURVIVABILITY OF GUARDRAIL TERMINALS

**Prepared by: Zhongguo (John) Ma, Assistant Professor and
Steven P. Mattingly, Assistant Professor
Dept. of Civil and Environmental Engineering
University of Alaska Fairbanks**

Date: August 1, 2000

FHWA-AK-RD-00-04

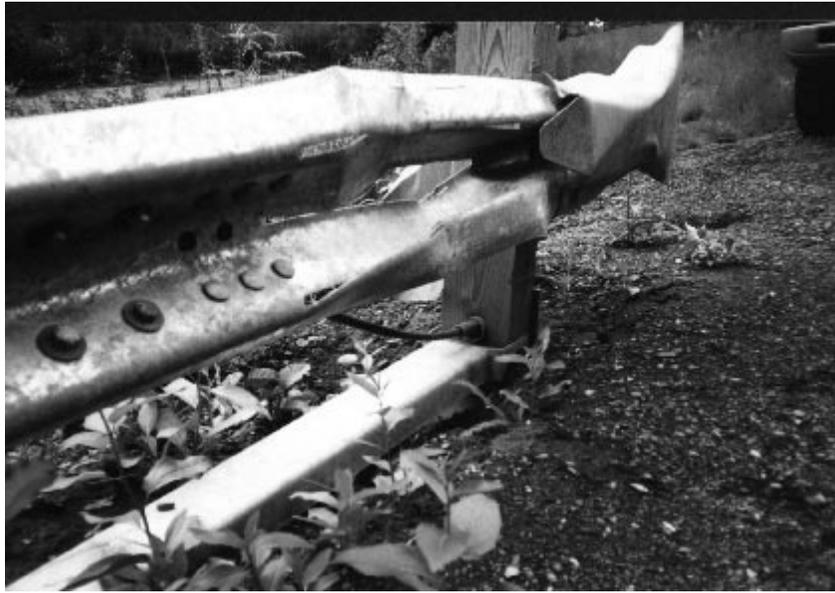
The Anchorage maintenance crews find the new slotted rail terminals (SRT-350s) fragile. The research team confirmed this statement through field visits. As an example, Fig. 1 shows the damage to the slotted area in the W-beam of SRT-350s. This type of damage could be caused by direct contact from the snowplow equipment or by snow-only contact, i.e. too much snow had been pushed against the slotted W-beam through snow removal operations parallel to the rail. The research team could not identify the exact cause of this damage. However, by comparing the slotted portion of the W-beam with the portion away from the slots shown in Fig. 1, it can be observed that the slotted portion has a lower bending resistance during snowplow operations.

Fig. 1 Damage to the Slotted Area in W-beam of SRT-350s

Although the maintenance crews did not know whether the damage shown in Fig. 1 was caused by the snow-only contact, they have observed significant damage due to routine winter maintenance in the Turnagain Pass region. In Valdez area, very heavy snow falls can be expected with at least 300 inches in the lower elevations and as much as 600 to 800 inches in Thompson Pass. The snow tends to be wet and heavy variety. Difting is a significant concern in many locations. The maintenance crews already attempt to operate three to four feet away from the terminal, but they are still observing damage to the new terminals.

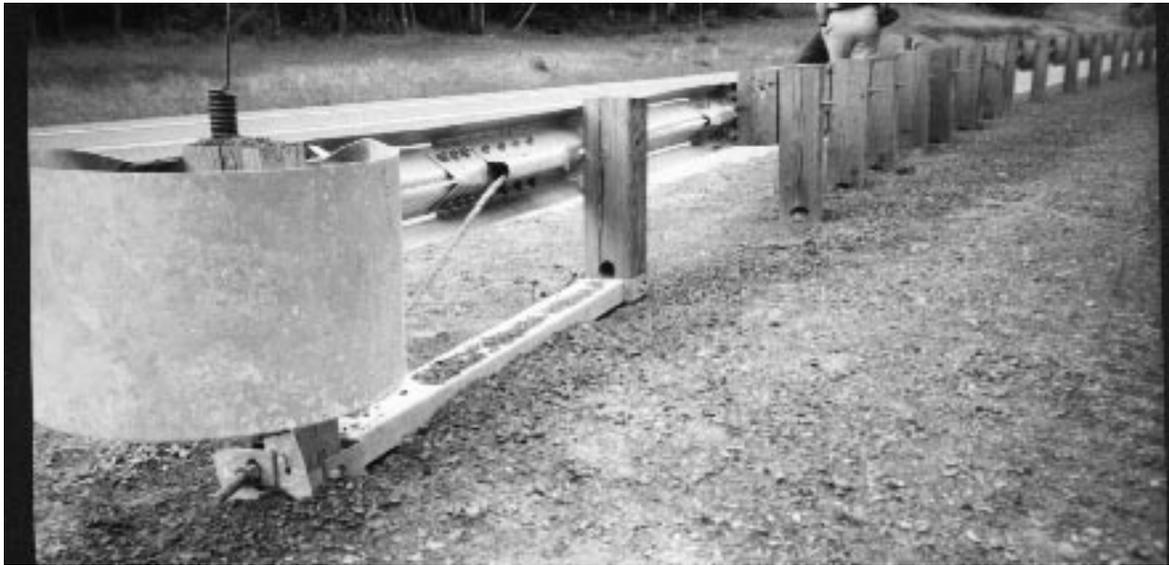
Another chief concern to these maintenance crews is the use of wooden posts for the terminal treatment that tend to shear away from its steel-tube base. It is important to point out that holes at the base of wooden posts (as shown in Fig. 2), similar in function to slots in the W-beam, intend to soften the new terminals during a vehicle collision. However, it does make them more fragile during the normal snowplow operations. After a post shears off its base, as shown in Fig. 3, the replacement effort is prohibitive because the base must be dug out of the ground.

Fig. 2 Wooden Posts with Holes

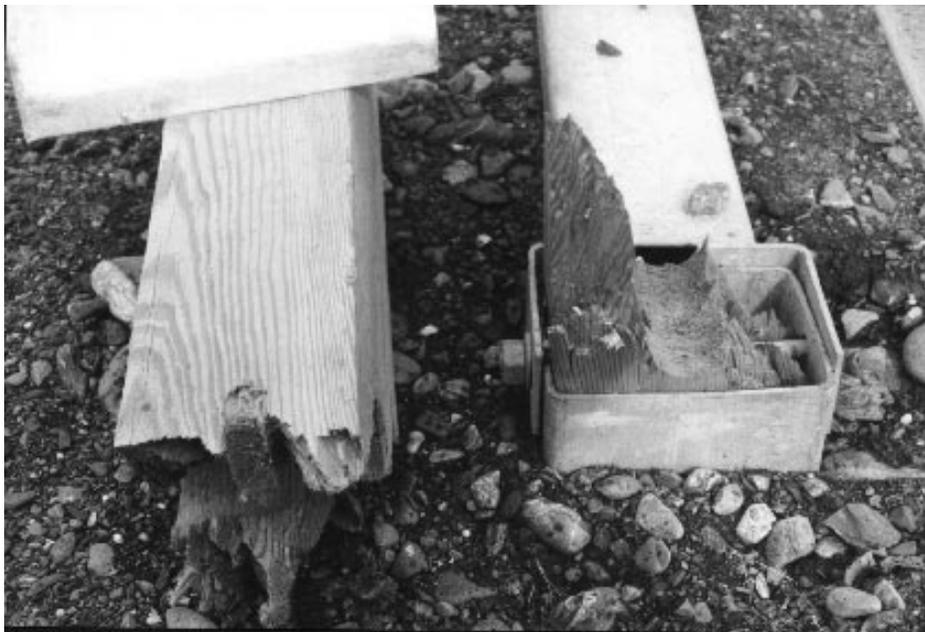
Fig. 3 Wooden Post Broke away from Its Steel-Tube Base

4. The maintenance crews in the Valdez area strongly support the investigation of both box-beam guardrails and the use of metal posts in the terminal as opposed to wooden posts. A careful research project may be designed to identify the ease of maintenance and likelihood of damage or failure associated with each post-type.

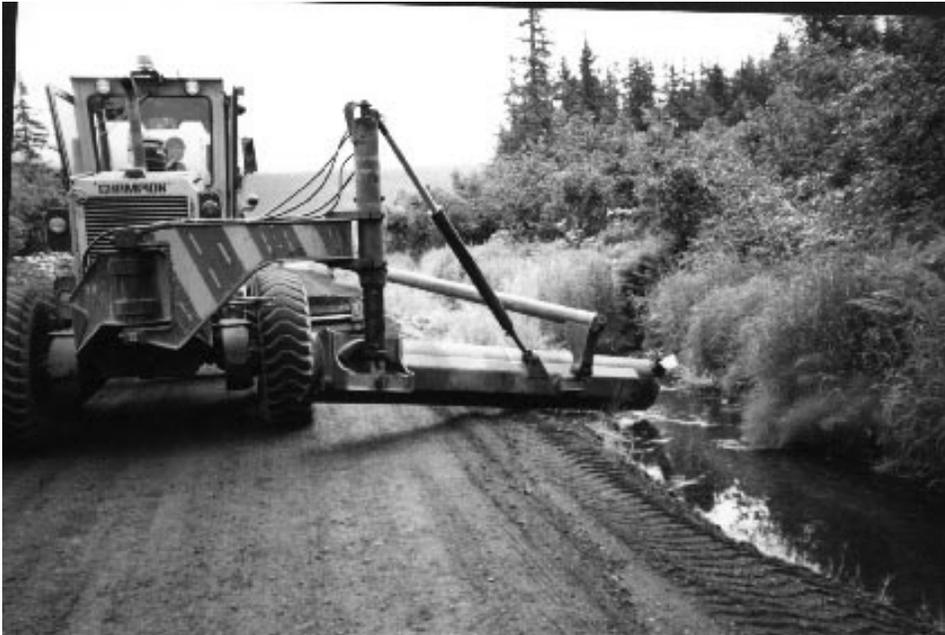
Fig. 4 A Grader with a Sloper Attachment

Similarly in Valdez area, the maintenance personnel also emphasize the vulnerability of the terminal when the grader operates in its vicinity. Specifically, the sloper attachment tends to catch on the posts and destroy the terminal.

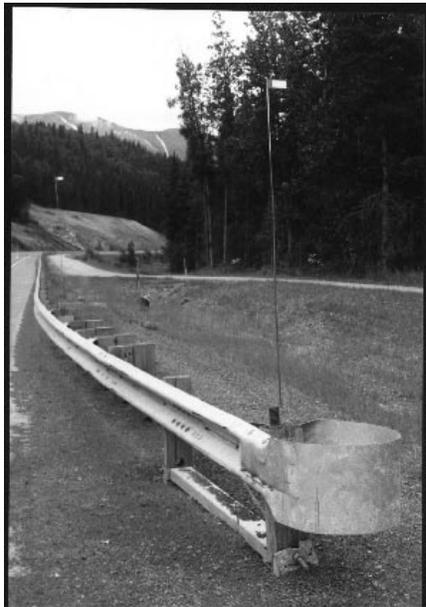
The new terminals in Turnagain Pass have been installed at the lower elevations, which only receives about a third (or approximately 130 in.) of the seasonal snowfall that is observed at the pass's peak. This region does not experience a large amount of drifting snow, but the heavy, wet snows seem to pose a special concern with regard to the terminal vulnerability. At this time, the terminal and guardrail ends in this section are marked with six-foot flexi-flags on spring steel, as shown in Fig. 6. This seems to be very effective and allows the operators to find these points throughout the winter. Additionally, the spring steel seems resistant to damage from winter maintenance activities.

Fig. 6 Six-foot flexi-flags Marker on spring steel

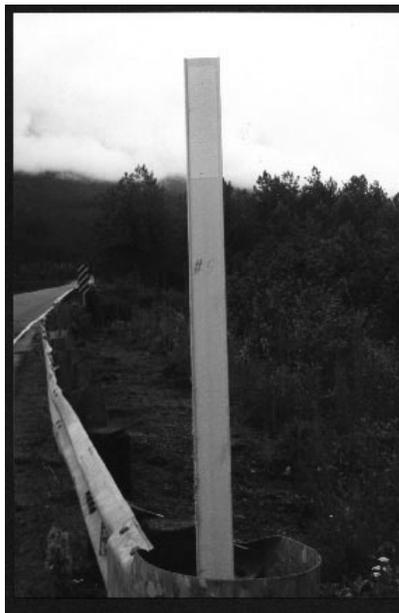
However, in Valdez area, only the terminal ends are marked with an eight-foot carsonite marker, as shown in Fig. 7. While the Valdez area crews are not sold on this marker, they believe it is the best they have found.

Fig. 7 The Eight-foot Carsonite Marker
