Forest Health Protection Alaska Region

R10-S&PF-FHP-2009-3

May 2009

Some impacts to paper birch trees tapped for sap harvesting in Alaska

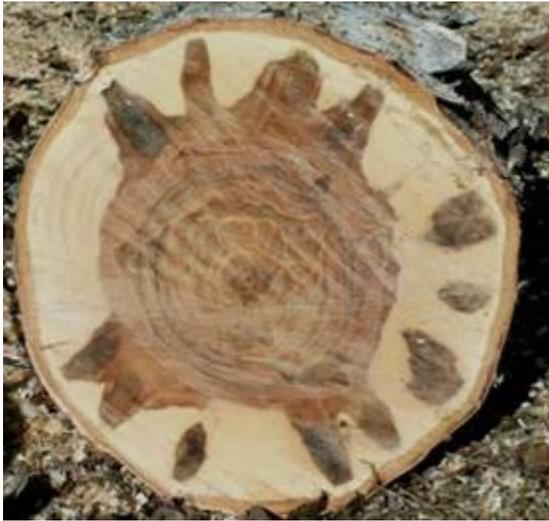
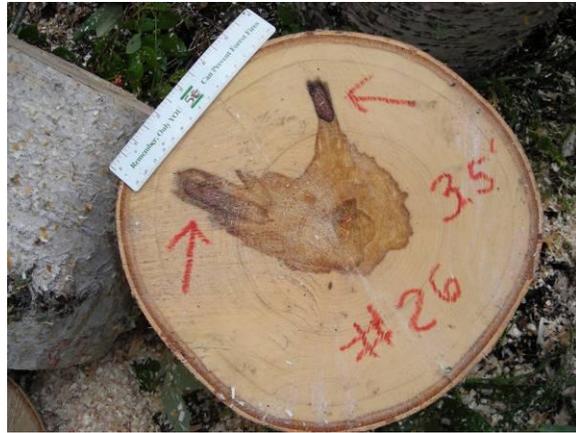
Regardless of the number of tap holes, years since tapping, or tap hole treatment, all tapped trees at both sites had sapwood red heart staining associated with every tap hole (Figure 3 and Figure 4). All taps could be readily distinguished and counted within a cross-sectional disk at 4.5 feet. The pattern of stain in the sapwood generally mimicked the length and shape of a tap hole, but was up to three times wider than the original 5/16th inch tap hole. A higher number of tap holes in a tree resulted in a higher proportion of stained sapwood (Figure 3 and Figure 4).

Sapwood stain columns from the tap holes all ended within the first 10 foot log, averaging 6.3 feet in length in the Cache Creek trees and 6.6 feet in the Eva Creek trees. Red heart stain not associated with the tap holes did occur in the main heartwood column of all tapped trees. This stain apparently pre-dated the tapping operations. Untapped trees at both sites, used as controls, had some red heart stain in the heartwood (Figure 5 and Figure 6); however, no signs of red heart stain or wood decay occurred in the sapwood of the control trees. The control trees provided confirmation that while red heart stain typically occurs in the heartwood of older birch, the introduction of stain into the sapwood of tapped trees was due to the tap holes.

Figure 3: Cache Creek tree 1 with stain around all 14 tap holes.

Figure 4: Eva Creek tree 26 with stain associated with both tap holes.

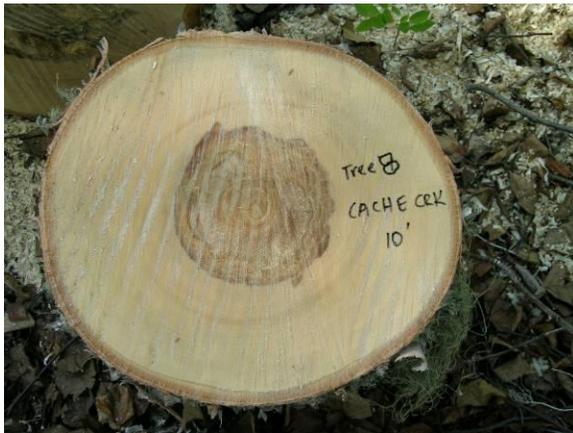
Figure 5: Cache Creek tree 8, a control tree, lacked sapwood stain.

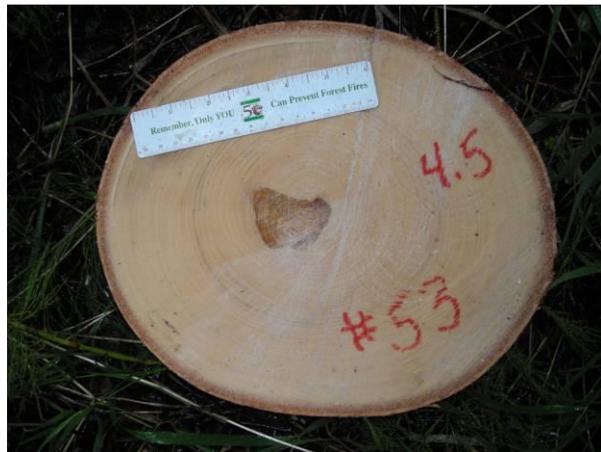
Figure 6: Eva Creek tree 53, a control tree, lacked sapwood stain.

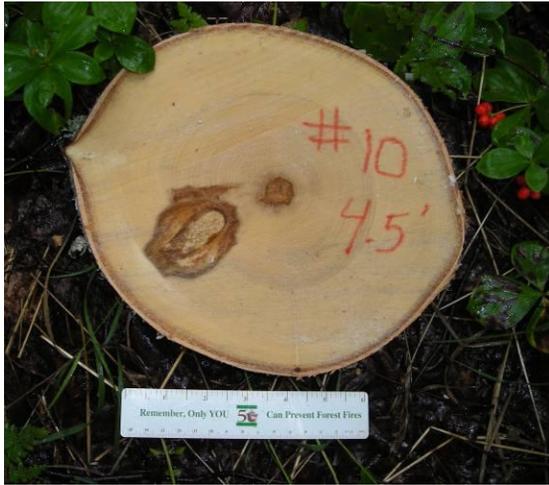
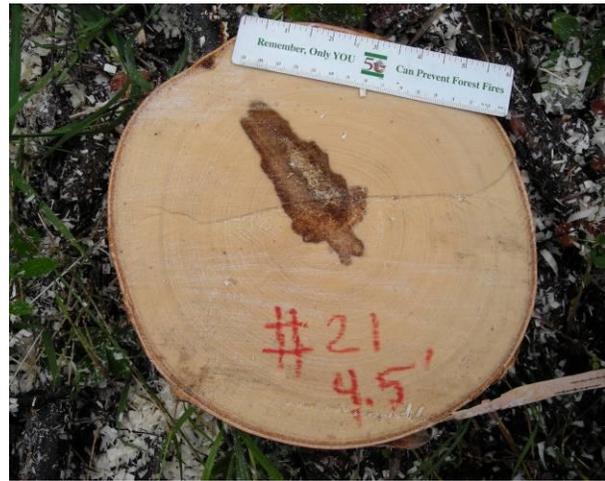
Eva Creek trees, tapped 17 years ago, had decay associated with tap holes in 55% of the trees (5 of 9) (Figures 7 and 8). Decay columns associated with the tap holes averaged 2.8 ft in length. Decay was present in tap holes regardless of treatment - corked, missing a cork, or never corked. Decay was confined or compartmentalized within the red heart stain.

Figures 7 and 8: Stain and decay associated with tap holes in Eva Creek trees 10 and 21, cut at 4.5 ft.

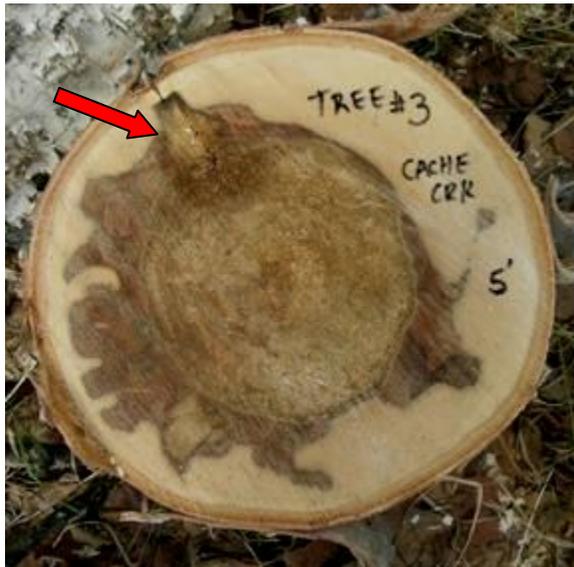
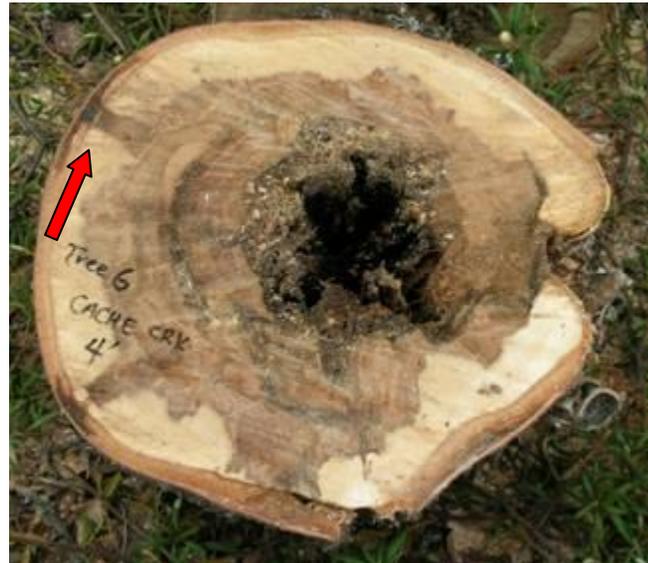
In the Cache Creek trees, softened and decayed wood was present in the tap holes of 1/3 of the dissected trees tapped since 2001 (Figures 9 and 10). Additionally, each tree at Cache Creek had at least one or more stained tap holes with dark streaks and black discoloration, suggesting that decay organisms may have invaded some tap holes, though decay has not yet had time to develop. Pre-existing stem decay was present in most of the Cache Creek trees complicating the connection between decay entering the tap hole via spores or invading through the pre-existing column. Regardless of how the decay was introduced into the tap hole, the presence of decay in the sapwood potentially reduces the health and vigor of a tree.

Decay columns associated with the tap holes did not exceed 1 foot; pre-existing decay columns, however, typically exceeded 10 feet at Cache Creek. Stem analysis of the control trees indicated that none developed sapwood decay over the same time period.

Figures 9 and 10. Cross-sectional cuts at dbh for Trees 3 and 6 at Cache Creek. Decay was present at some tap holes (red arrows) in each of these trees.

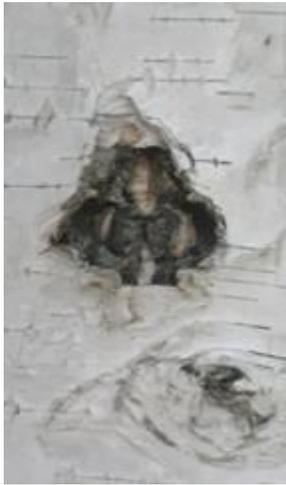
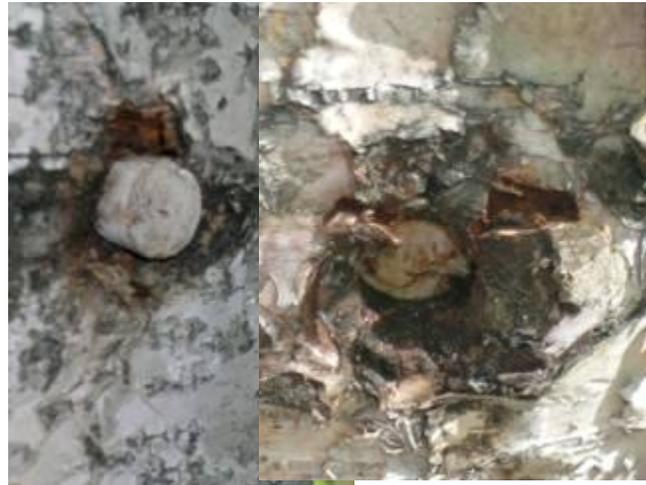
Some trees at the Eva Creek site were corked or had spouts still in the trees since 1990. Many tap holes were difficult to locate 17 years post harvest because the trees had effectively closed the tap hole naturally (Figure 11). Trees that were corked at some time in the past 17 years were in various states of retaining or losing the cork (Figures 12 and 13). The presence of corks and imbedded spouts both inhibited the natural closing of the tap holes. Where corks had popped out, the wounds were re-opened to insects and decay organisms.

Figures 11, 12, and 13: From left to right, effectively closed tap hole that was never corked, cork half way protruding from the tree, cork deeply imbedded in the tree.

Guideline 12 recommends corking tap holes upon removal of taps, however, this treatment is not supported by the pilot study. The cork treatment was not effective in preventing stain or decay in sampled trees. Corks inhibited the natural closing of the tap holes, may seal fungal spores within the tap hole, and were associated with the presence of a canker fungus, *Nectria galligena*. Thus, corking trees after sap harvest appears unnecessary and may even be harmful to birch trees. We recommend that the ABSA revise their guidelines to eliminate reference to corking. Tree tapping Guideline # 12 should read "Remove spouts at the end of **each** season; may spray hole with pure water".

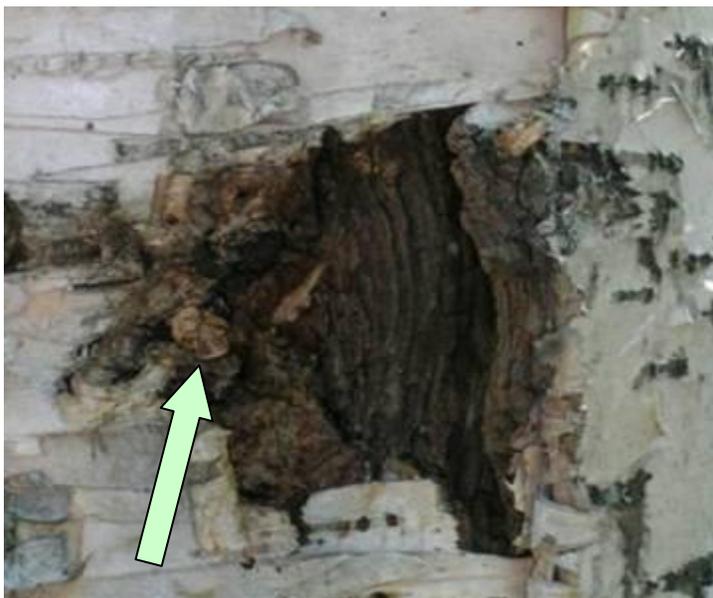
Several trees at the Eva Creek site developed the stem canker fungus *Nectria galligena* at corked tap holes or surrounding imbedded spouts (Figure 14). No signs of *N. galligena* were found associated with uncorked holes or tap holes that healed naturally at Eva Creek. To date, there are no signs of this fungus on the Cache Creek trees. *N. galligena* is a common canker fungus of birch in Alaska that readily invades wounds and dead branches. It results in cambial death and increased stem breakage at the infection site (Holsten et al. 2001). The ability of *N. galligena* to exploit the corked tap holes and old imbedded spouts is similar to that reported by Lorenz (1944). He found that nearly half of increment borer holes plugged with sterile dowls had *N. galligena* cankers surrounding them.

Figure 14: The canker fungus *Nectria galligena* associated with a corked tap hole. Arrow points to the cork remnant. Dead flaring bark and concentric sapwood rings to the right of the cork are signs of invasion by this canker fungus.

Corking tap holes does not appear to be an effective means of inhibiting stain and decay or preventing infection by the canker fungus *N. galligena*. It is likely that the corks may be trapping fungal spores effectively providing an entrance court for fungi, rather than preventing their introduction. Corking thus appears to be an unnecessary, and perhaps harmful, treatment for tapped birch trees. We suggest that taps be removed in a timely manner after harvest operations to reduce the likelihood of canker fungi introduction.
