THE NORTHERN ENGINEER

Volume 17, Number 1
Spring 1989

| Deteriorated Building Panels at Sondrestrom, Greenland Charles Korhonen | 7 |

Deteriorated Building Panels at Sondrestrom, Greenland

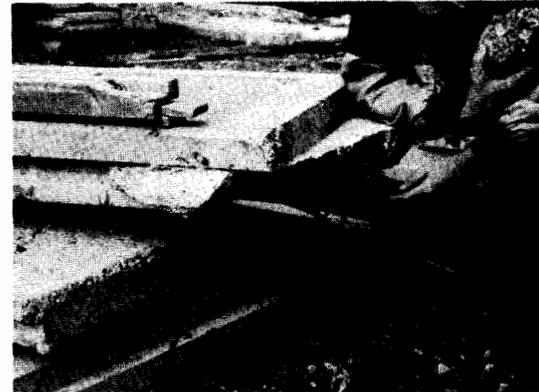
Figure 1. Unused wall panels stored near the runway, Sondrestrom Air Base, Greenland.

stored since 1954 near the SAB runway (Fig. 1) were sent to WES for analysis. A microscopic examination showed that this concrete is highly susceptible to freeze-thaw deterioration in the presence of water because it was not air entrained. Air entraining is generally acknowledged to increase greatly concrete's resistance to this type of deterioration.

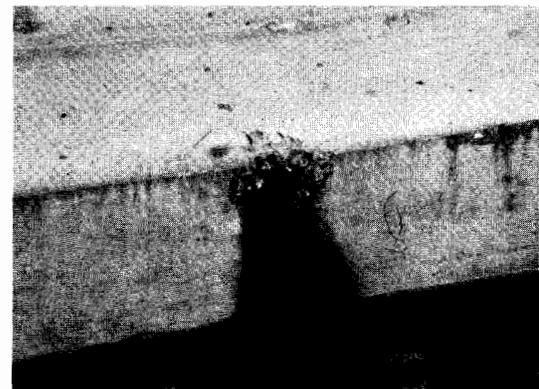
Figure 2. Typical rust streak on exterior of building. Note the dark, iron-rich stone at its center.

Usually when one thinks of corrosion in concrete, visions of rusted reinforcing steel come to mind. Figure 2 suggests that this was the case in Sondrestrom, since rust streaks like the one shown are evident on the exterior surfaces of these buildings. However, a closer look shows that the rust is emanating from a point source, not from cracks corresponding to reinforcement locations. I chipped out several of

these areas and in each case found a rusted, iron-rich stone. Chipping deeper revealed even more of this material, except that it was not rusted at depths greater than about 3/8 inch. Unless it begins to expose more and more aggregate, this near-surface rusting is not a structural problem.

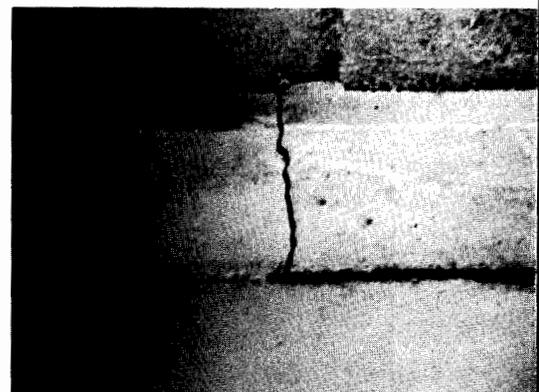
Figure 3. Grade beam cracked and separated from floor, leaving a 1/4-inch crack.

My measurements and observations suggest that most of these buildings have settled differentially. Cracks and separations in the structural framework at several locations were evidence of this. For example, in the corner of one building a section of grade beam (Fig. 3) had cracked and separated from the floor slab by as much as 1/4 inch but had remained in contact with the floor along the rest of its length. In another case, an equipment support rod that was securely bolted to the ceiling and floor had bowed (Fig. 4). A comparison of the height of the bowed rod with an unbowed rod showed that the ceiling-to-floor distance had decreased by 1/16 inch.

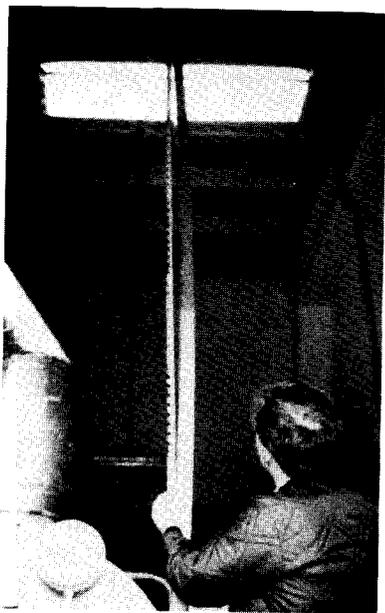
Figure 4. Bowed equipment support rod, representing a 1/16-inch movement.

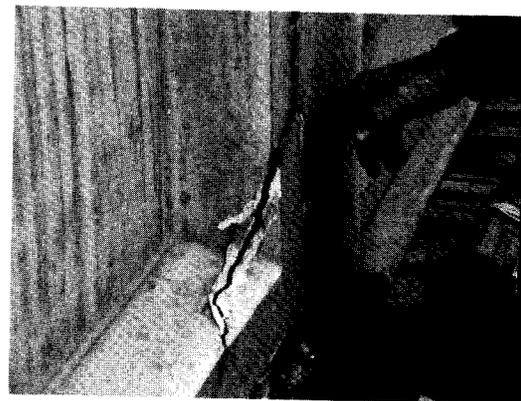
Figure 7. Diagonal cracks that have spalled off panel corners.

As the temperature changes, the concrete panels that clad these buildings are constantly expanding and contracting. To accommodate this movement, each wall panel has been separated from adjoining ones by a 3/8-inch joint and weather sealed with a flexible metal waterstop. Some joints have also been filled with a rigid cement mortar. Wherever this mortar has been used, the panels have not been free to expand. As a result, stresses have built up to the point where the panel edges have developed two types of cracks along these joints: short hairline cracks perpendicular to the panel edge (Fig. 6) and diagonal cracks at the panel corners (Fig. 7).

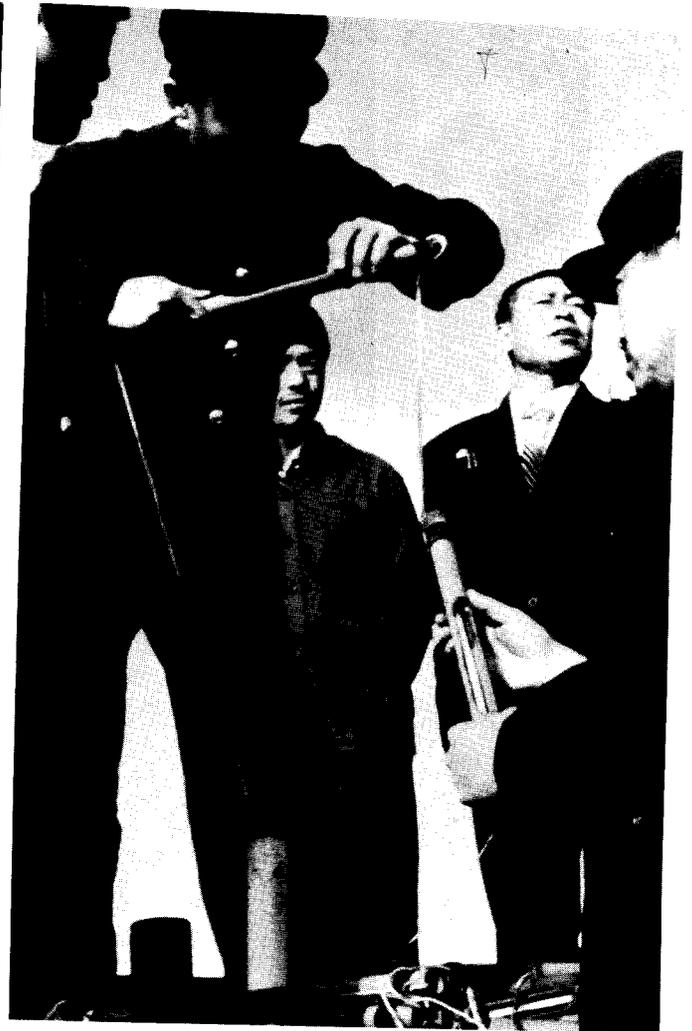
Chinese technician reading temperatures at the south abutment of the bridge at Jinlin. (Larry Sweet photo.)

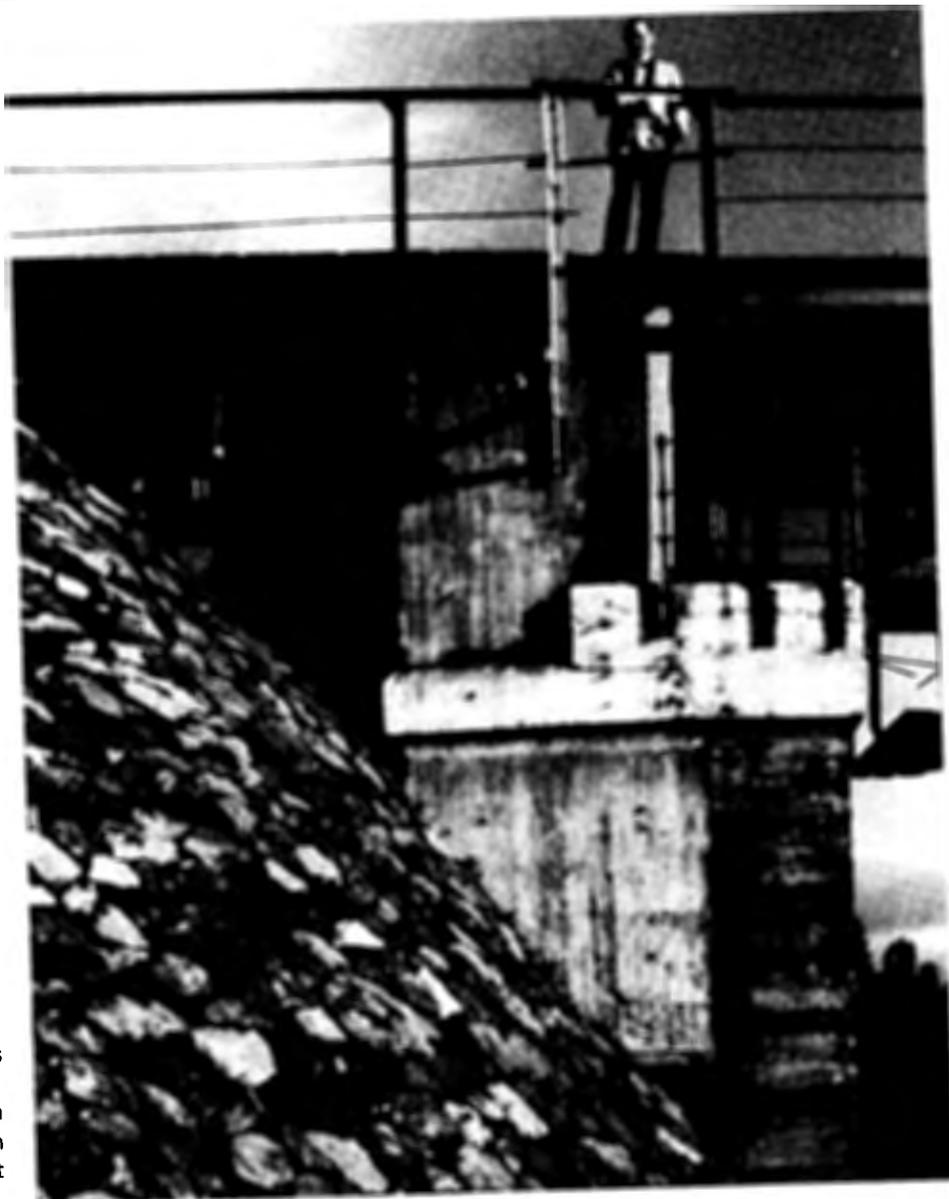
The south abutment of the bridge at Jinlin on the Yalin railroad in Inner Mongolia. The abutment was built on permafrost and has settled. The light-colored concrete near the center of the photo is a cap that has been inserted to level the bridge. (Dave Esch photo.)

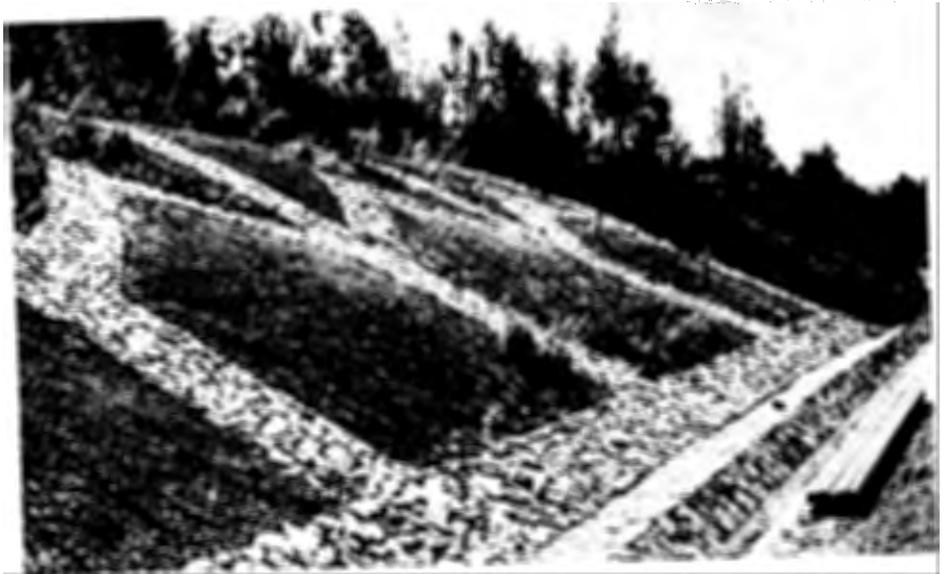
Right, slope stabilization along the Yalin railroad line south of Mangui. Underdrains are used to remove excess water that had previously caused serious icings on the track. Continuing slope movement is shown by the partially closed rock-lined drainage ditch.

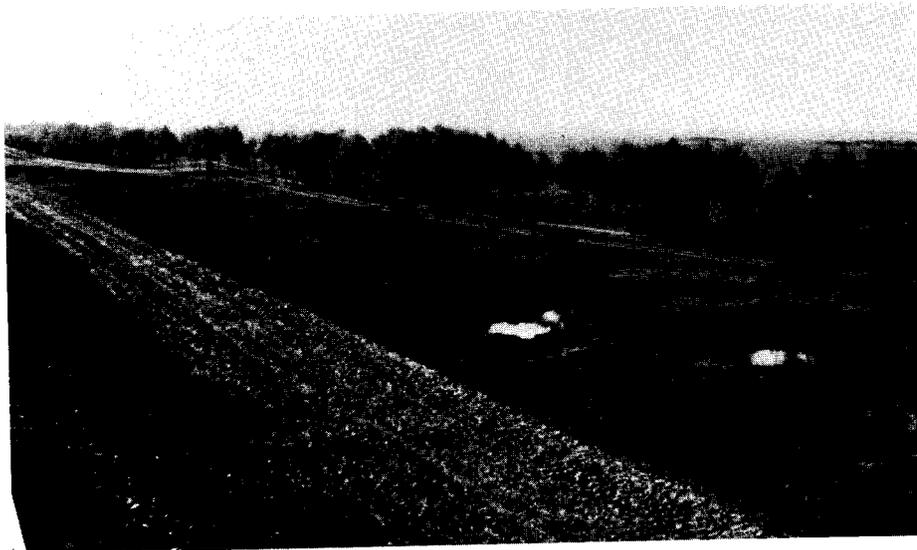
Left, edge of the railroad along the Yalin Line between Qiqihar and Yakeshi shows the source of the embankment. Material was hand dug in carefully laid out plots to determine the amount that had been excavated by each crew of workers. (Larry Sweet photo.)

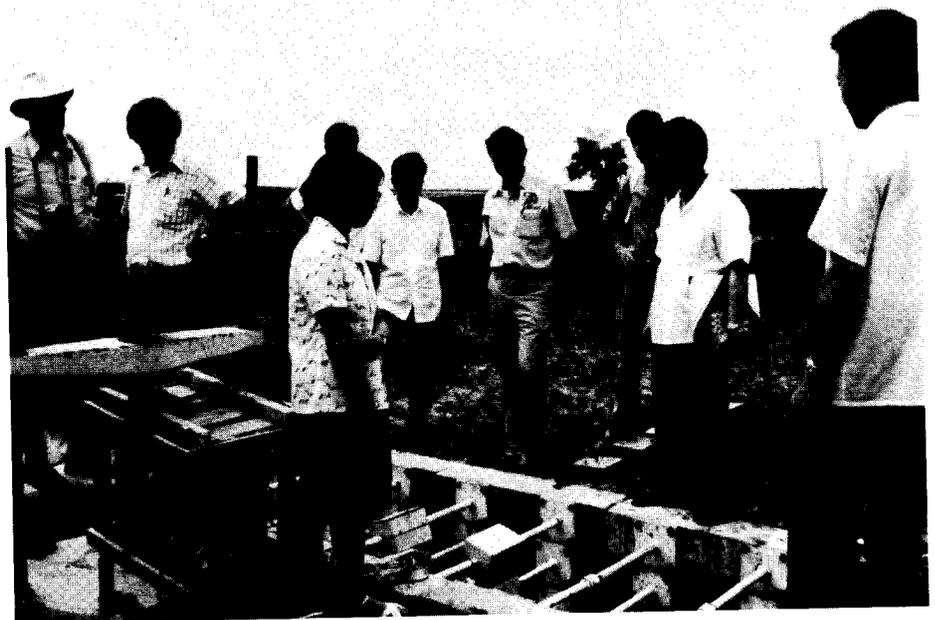
Left, concrete panel floor assembly placed on concrete piles for building foundations in Mangui, the northern end of the Yalin railroad in Inner Mongolia. The permafrost conditions in this area are similar to those in interior Alaska and cause the same sorts of construction problems. (Larry Sweet photo.)

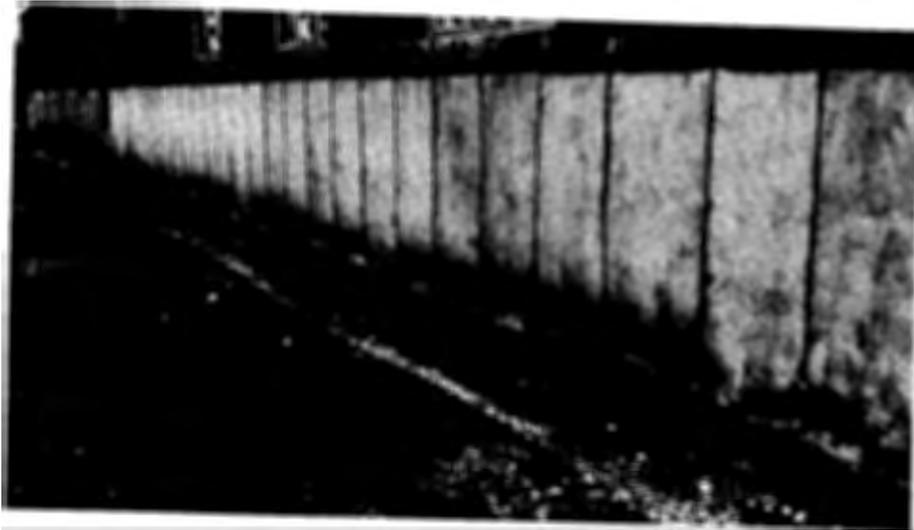
The foundation for a large apartment building to house railroad workers in Mangui. The structure, built on permafrost, was elevated approximately 1 meter above the ground surface. The holes near ground level provide ventilation to the space under the building. (Larry Sweet photo.)

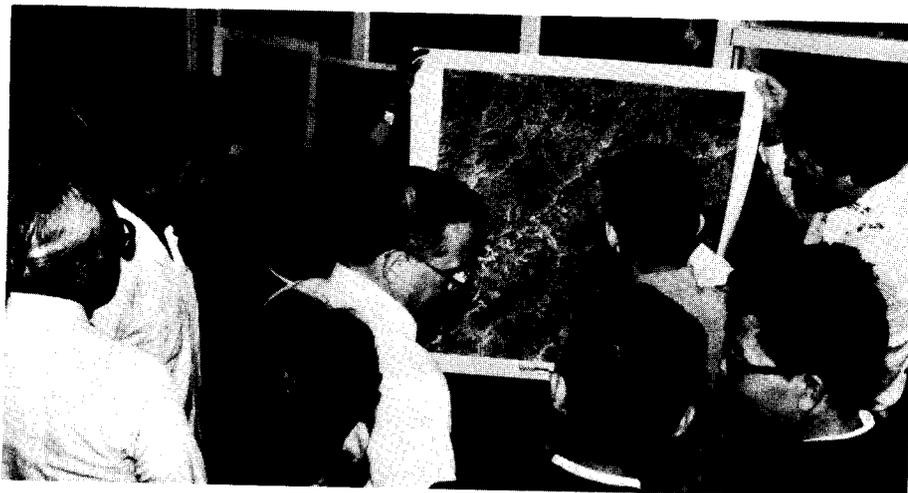
Ray Kreig, Richard Reger, and Troy P  w   explain the details on a satellite photo that shows the surrounding area of Inner Mongolia to Chinese engineers at the Yakeshi Forestry Survey and Design Institute. (Larry Sweet photo.)

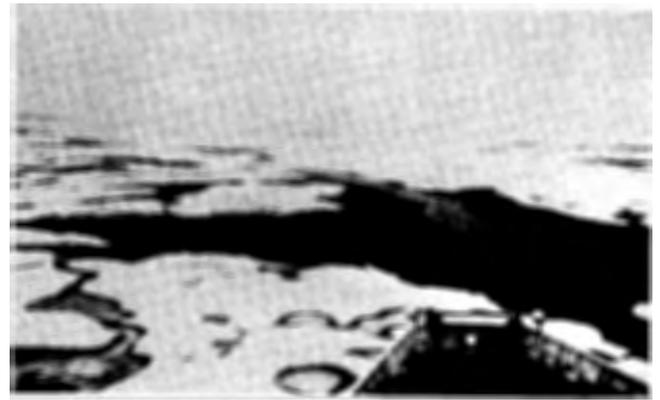
A lead in the vicinity of the selected floe north of Barter Island as it appeared from the icebreaker *Polar Sea*. (Photo by Pat Hardisty.)

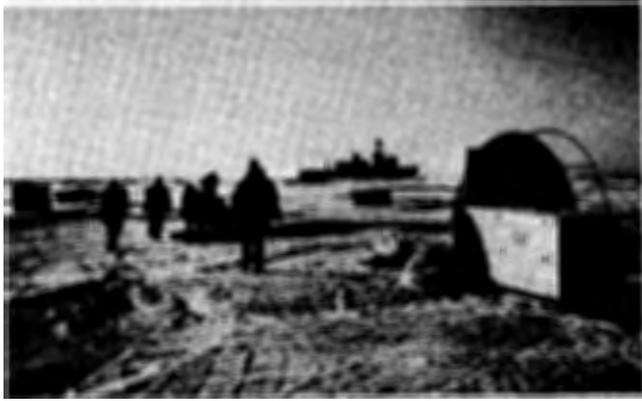
Crew unpacks equipment in order to set up camp on the floe. The Polar Sea can be seen in the background. (Photo by Pat Hardisty.)

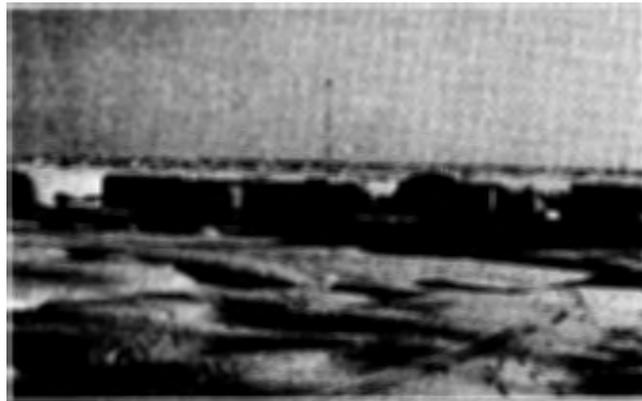
Established research station on the selected ice floe. (Photo by Pat Hardisty.)

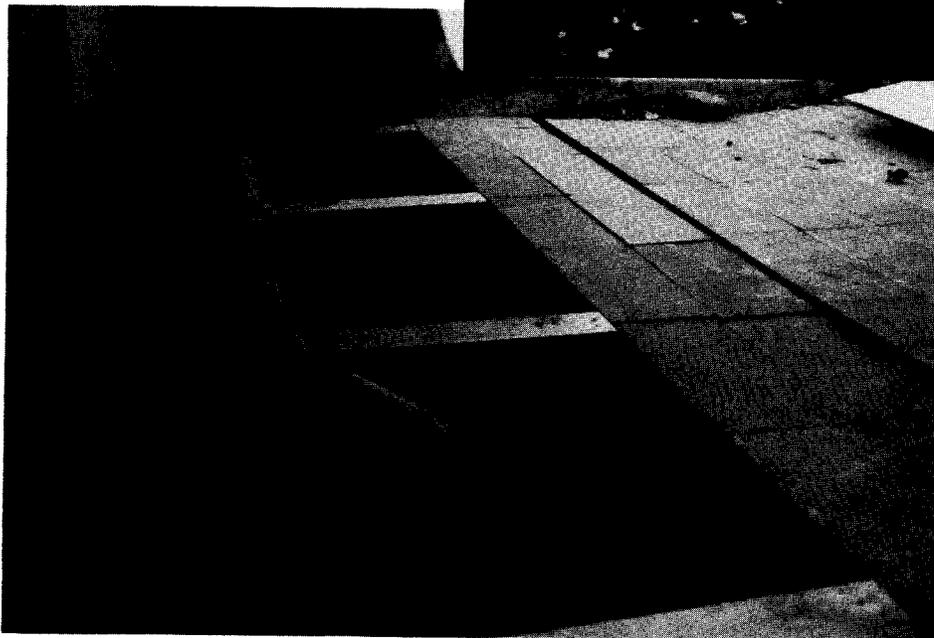
View of supply plenum and duct opening to the mechanical room beyond. Note 4" drain pipe penetration.

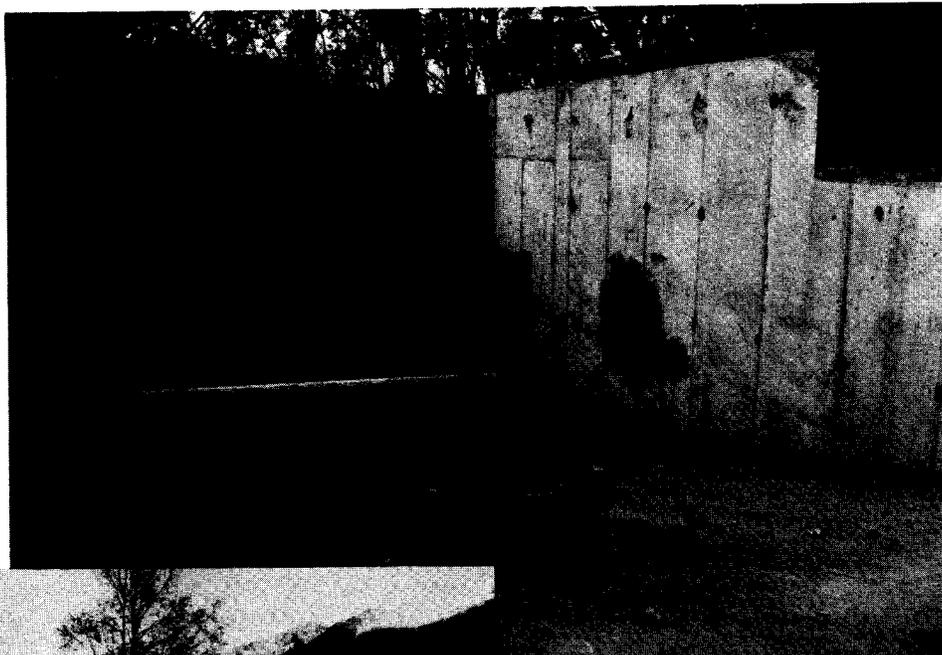
Upper end of greenhouse pit before back-filling. The 16"-diameter duct is connected to the air return plenum below the slab.
