IMPACTS OF FISH WASTE PILES IN ALASKA

A Project

MASTER OF PUBLIC HEALTH

December 2015

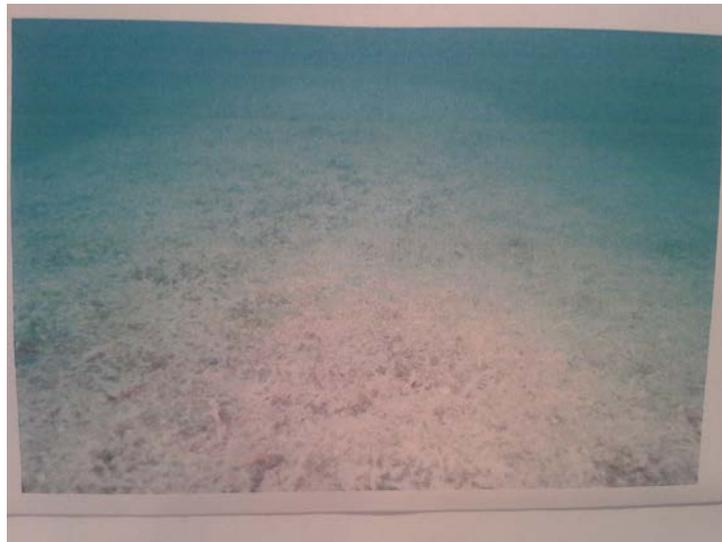
Figure 1. An overview of a fish waste pile in Sitka (Seafood Producers Cooperative, 2005)

Two tools currently used to measure the size of fish waste piles in Alaska are dive surveys and benthic assessments. The primary tool used is a dive survey, in which a team of divers visually evaluates the fish waste pile according to a prescribed methodology. Historically, divers collected measurements of the pile using rulers and tape measures while on the seafloor. With the advent of technology, some divers are utilizing AutoCAD-type of software and GPS to measure the size of the pile. Figures 1 and 2 are pictures taken during dive surveys.

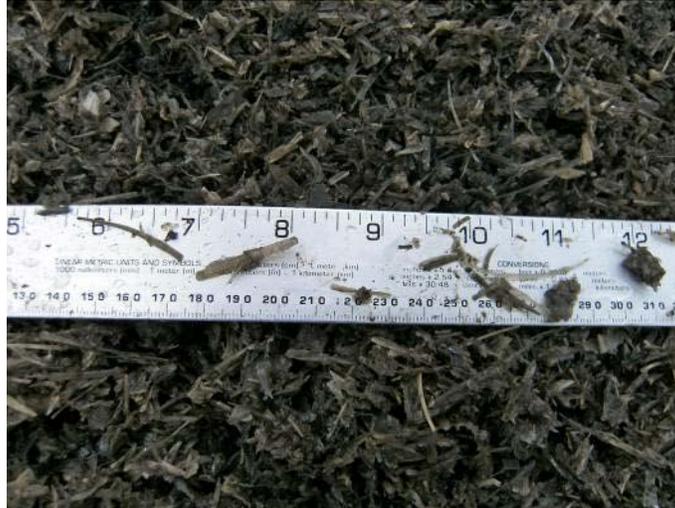
Figure 2. Picture taken during a dive survey (Haggitt, 2011b)

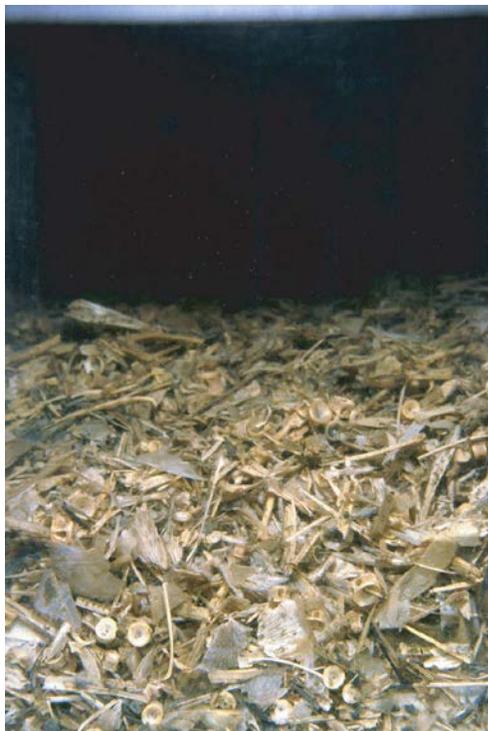
Figure 3a. Sediment profile image of a Ketchikan fish waste pile (Germano, 2004)

Benthic assessments utilize sediment profile imaging, which is collected with a specialized camera. The camera is lowered into the sediment and a cross-section picture of the sediment is taken. Typically during benthic assessments, water quality measurements (e.g., dissolved oxygen, salinity, conductivity) are also collected from the vessel. Scientists then evaluate the sediment profile images and formulate conclusions regarding the health of the benthic community and conditions of the seafloor.

Sediment profile imagery can be a powerful tool that can map gradients in sediment type, biological communities, or disturbances from physical forces or organic enrichment (Germano, 2004). It can also be helpful in deeper water where diver visibility is reduced. Figures 3a and 3b are examples of sediment profile images taken during benthic assessments.

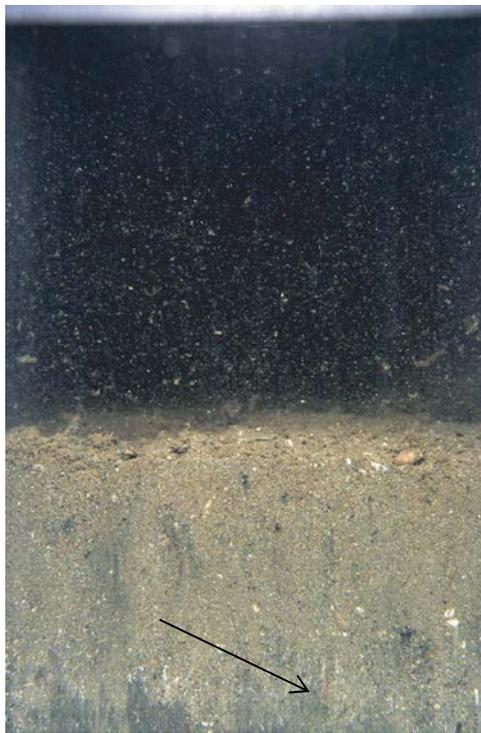
Figure 3b. Stage 3 taxa (e.g., worm) noted by arrow (Germano, 2004)

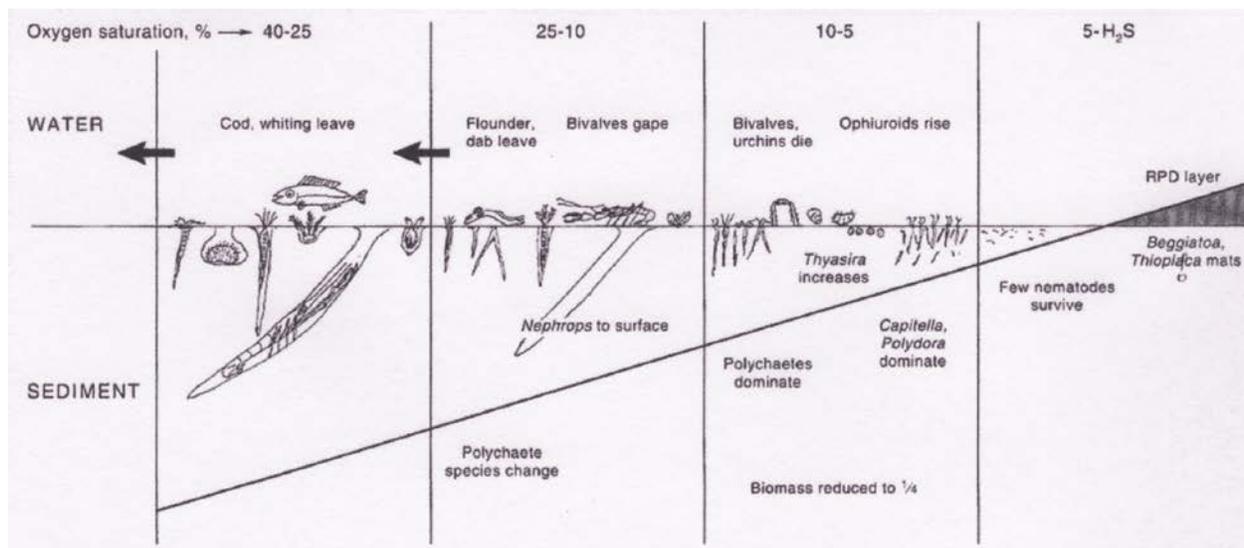
Figure 4 is a model of the general behavior response pattern observed in studies evaluating impacts to benthic communities from organic enrichment (Rosenberg, 2001).

Figure 4. General ecosystem responses
