Stabilization of Horseshoe Lake Road using Geofibers and Soil-Sement®

Final Report

AUTC # S12609

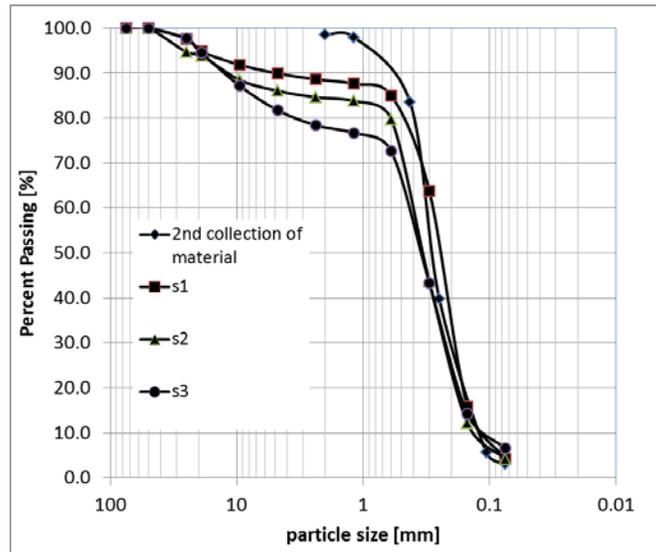
The sand available at the site was tested for general soil properties in the laboratory at the University of Alaska Fairbanks. Tests performed to determine general soil properties were Sieve Analysis ([ASTM 422](#)), Modified Proctor Compaction ([ASTM D1557](#)), and Specific Gravity ([ASTM 792](#)). The particle size distribution curve is shown as [Figure 2](#). The original Horseshoe Lake samples are represented as S1, S2, and S3 on the particle distribution curve. Additional Horseshoe Lake sand was collected for testing because the initial collection did not yield enough material to finish all testing. In order to verify that the second material collected was relatively similar to that of the first samples, the grain size was examined. In [Figure 2](#), the curve titled “2nd collection of material” corresponds with these samples. The material that did not pass a #4 sieve was discarded prior to the ASTM 422 standard sieving process. This was done to remove some small organic material; there are no data points on the graph for that region. It should be noted that all tests after sieve analysis (CBR, specific gravity, modified

proctor compaction) were conducted with the material retained on the #4 sieve removed. The Horseshoe Lake sand is classified as SP, poorly graded sand according to USCS classification. The in-situ moisture content was found to be 3.3% and the specific gravity was determined to be 2.73.

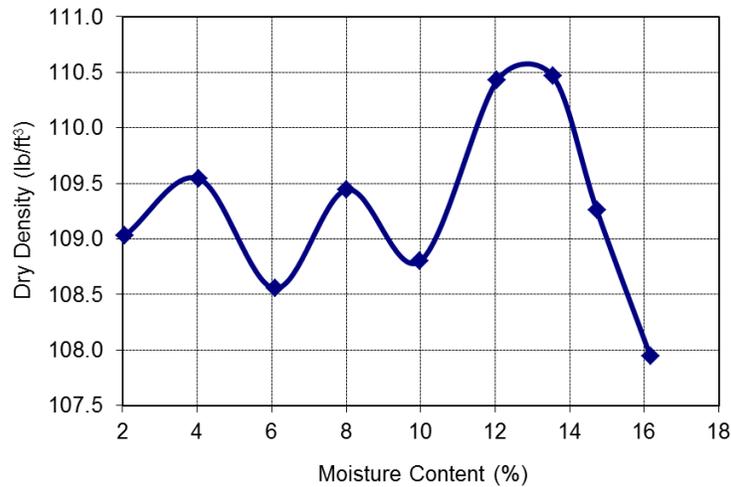
Figure 3: Modified Proctor Curve

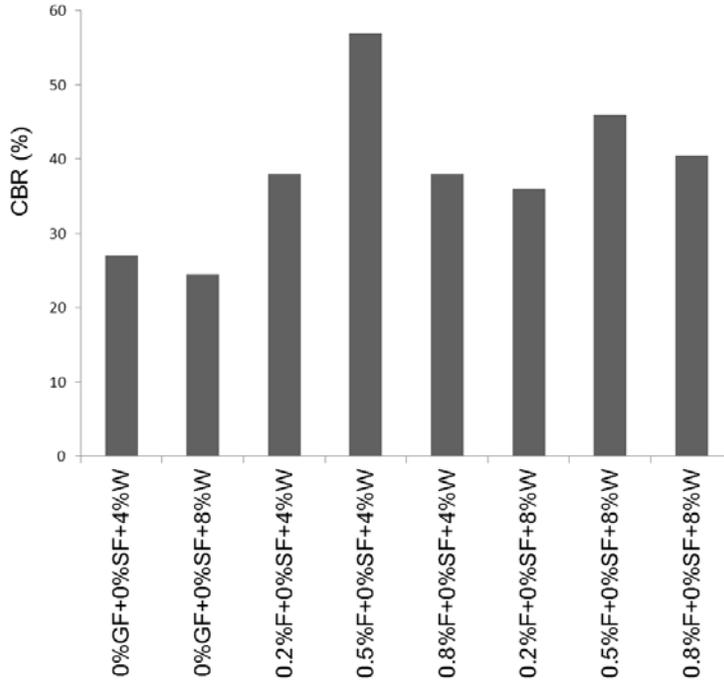
Figure 4: CBR values of Horseshoe Lake sand treated with fibers

The initial phase of laboratory testing examined the CBR value when varying amounts of fiber percentages were included. The fiber percentages used were 0.2%, 0.5%, and 0.8% by the dry weight of the soil; these were chosen based on the previous research by [Gullu and Hazirbaba \(2010\)](#). The fibers used during testing were fibrillated fibers two inches in length. The samples used in the fiber-only tests were unsoaked (that is, immediately after compaction the samples were tested). Only two moisture content levels were tested, 4% and 8%, because the change in dry density is fairly low (less than 1 lb/ft³). The results of the fiber-only testing are presented in [Figure 4](#). The optimum fiber content in both cases is 0.5% by the dry weight of the soil.

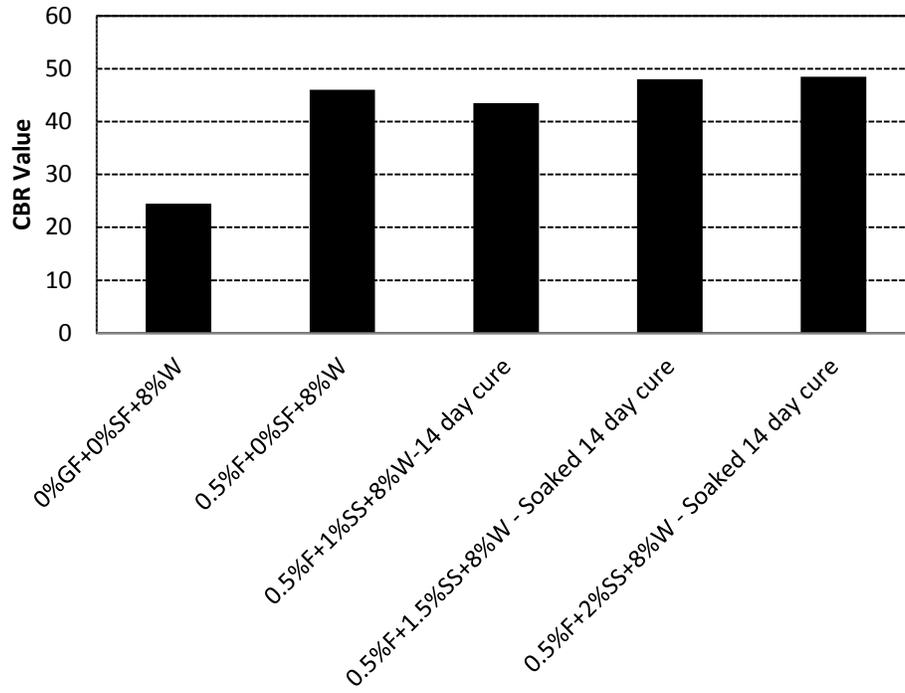
Figure 5: CBR results of samples at 8% moisture treated with Soil-Sement

The Soil-Sement came with a manufacturer’s recommendation to use 1 gallon of Soil-Sement for a section of 20 square feet and a section depth of 4 inches. The unit weight of the Soil-Sement is 1.08g/mL based on our laboratory evaluation; this yields a dosage percentage of nearly 2% by the dry weight of the soil. The final dry-weight percentages of Soil-Sement used for testing were 1%, 1.5%, and 2%. Two moisture contents, 4%, and 8%, were examined for testing with Soil-Sement with and without fibers. The results showed that for samples containing 8% moisture and treated with Soil-Sement, all treatment dosages produced relatively similar CBR results (around 40; see Figure 5). The samples with 4% moisture content and 2% Soil-Sement start to show a noticeable increase in the CBR value. Test results for samples with 4% moisture, Soil-Sement, and geofibers is shown in Figure 6.

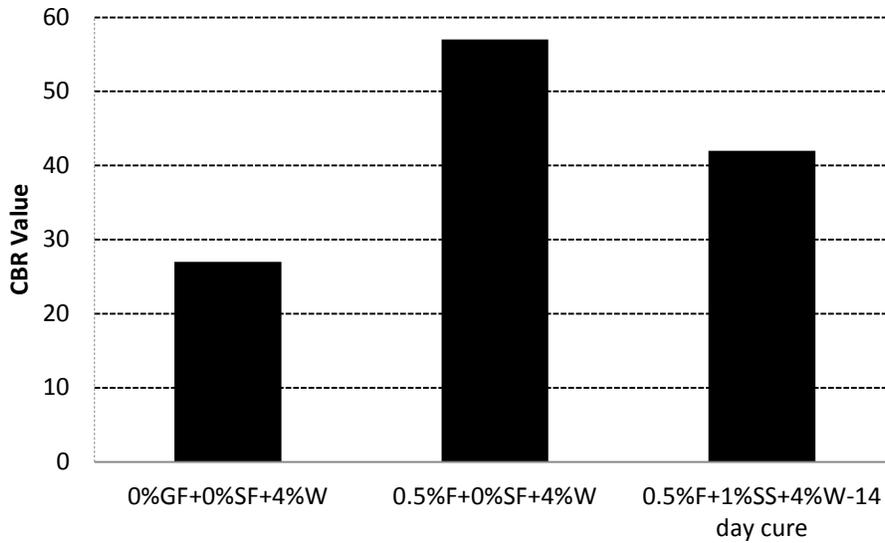
Figure 6: CBR results for samples at 4% moisture with Soil-Sement

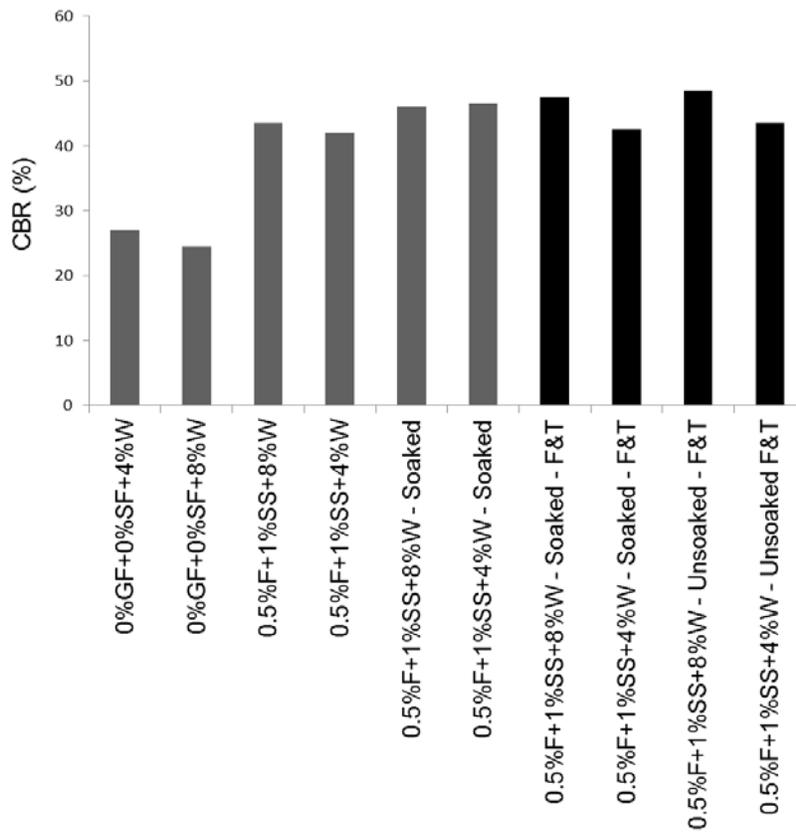
Figure 7: CBR test results of using both Soil-Sement and geofibers

The results of the freeze-thaw testing showed that samples treated with Soil-Sement showed little to no degradation in CBR value for either the soaked or the un-soaked samples. The results of the freeze-thaw CBR testing are presented in [Figure 7](#). The data indicates the material is not freeze-thaw susceptible, an important consideration in cold climates.

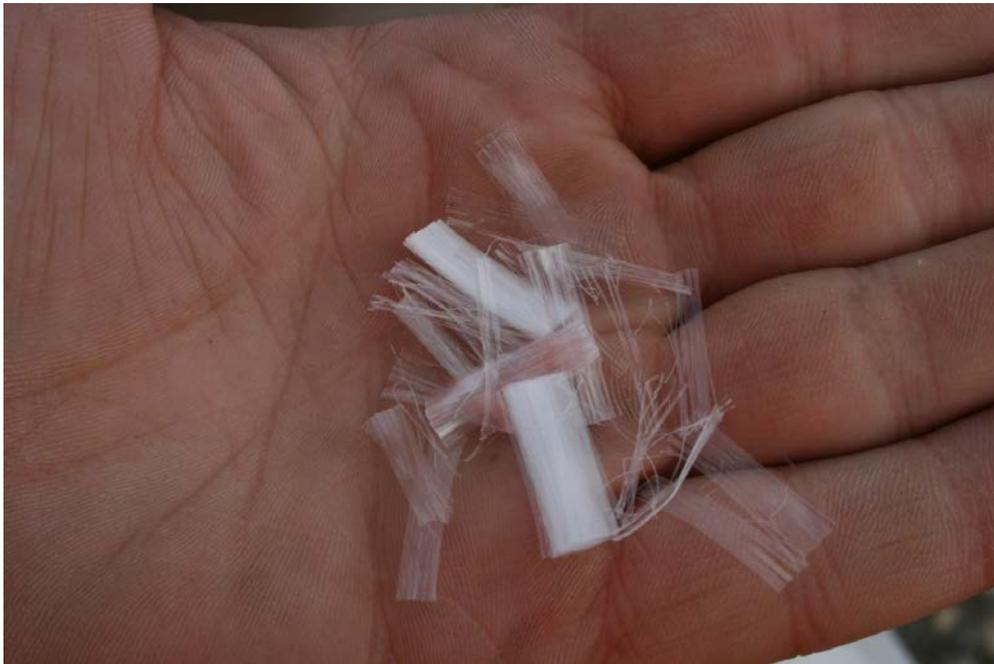
Figure 8: Fibers used on Horseshoe Lake road

The geofibers were shipped on crates in large boxes; each box contained twenty 30 pound bags. The geofibers used at Horseshoe Lake were $\frac{3}{4}$ inch fibrillated fibers, white in color. In contrast, the geofibers tested in the laboratory were 2 inches long and had some added carbon for UV protection. These shorter fibers were selected by the provider who through experience has found the shorter fibers easier to mix with soils. This substitution was made without consultation with the research team. A few images present the fibers in more detail; [Figure 8 shows a close-up of the \$\frac{3}{4}\$ inch fibers](#), held in the palm of a hand. Rather than delay the project, the research team decided to proceed with the $\frac{3}{4}$ inch fibers.

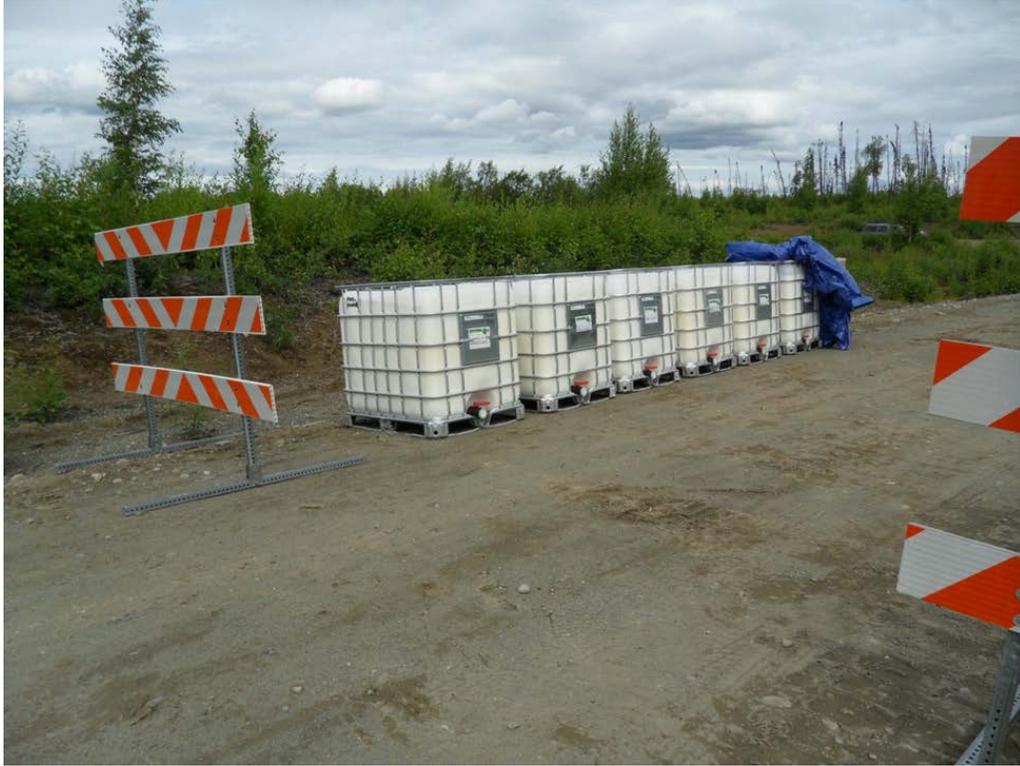
Figure 9: Soil-Sement shipping totes

Based on the test results, the synthetic fluid used for liquid stabilization on the Horseshoe Lake test site was the Soil-Sement[®] engineered formula produced by Midwest Industries. This is a polymer emulsion designed for dust control, erosion control, and soil stabilization. The Soil-Sement was shipped in six 500 gallon totes. [Figure 9](#) shows the six totes at the construction site. The Soil-Sement is white and is highly viscous, which posed problems for pumping the fluid into the water truck. In the end, the contractor elected to lift the totes above the water truck with a fork lift and gravity-feed the Soil-Sement. [Figure 10](#) shows an image of the fluid diluted with water coming out of the back of the water truck.

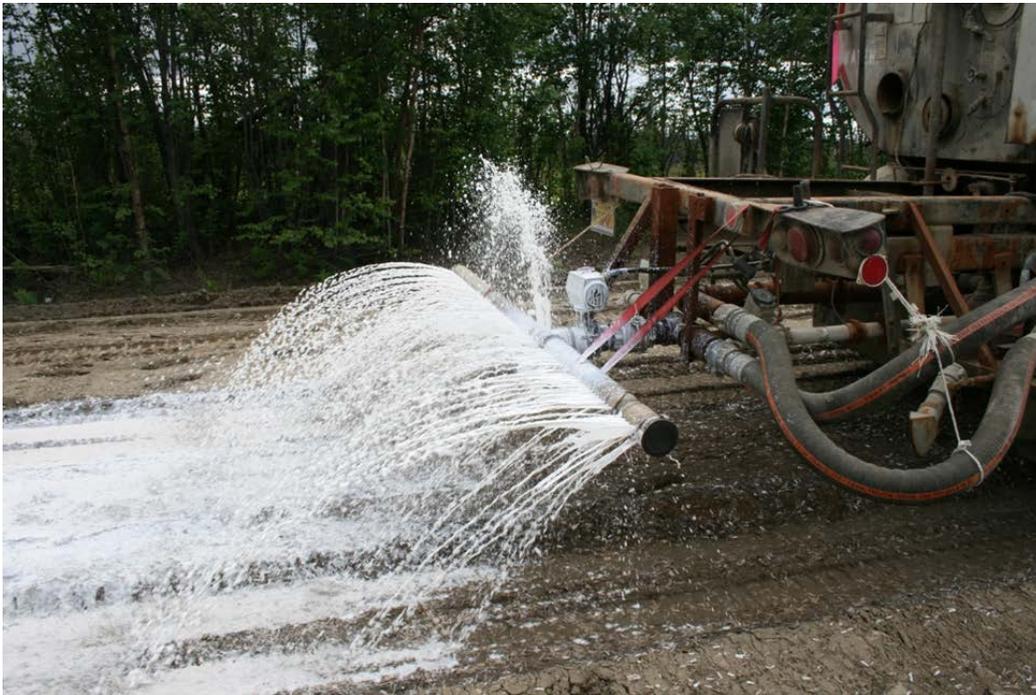
Figure 10: Soil-Sement applied from water truck

Application of the Soil-Sement was completed using the 3000 gallon water truck ([Figure 10](#)). As noted above, the main problem encountered was transferring the Soil-Sement to the water truck. Elevating the containers so that gravity-feeding increased the pumping speed overcame this issue, albeit with some delay. The Soil-Sement was diluted with water to aid application as well as to bring the soil closer to the optimum moisture content. Field moisture content tests were conducted to determine the in-situ moisture content of the soil, which was found to be 8% on average before construction. Several hours elapsed between mixing the fibers with the soil and application of the Soil-Sement because of the delaying getting the Soil-Sement into the water truck. New measurements, taken after

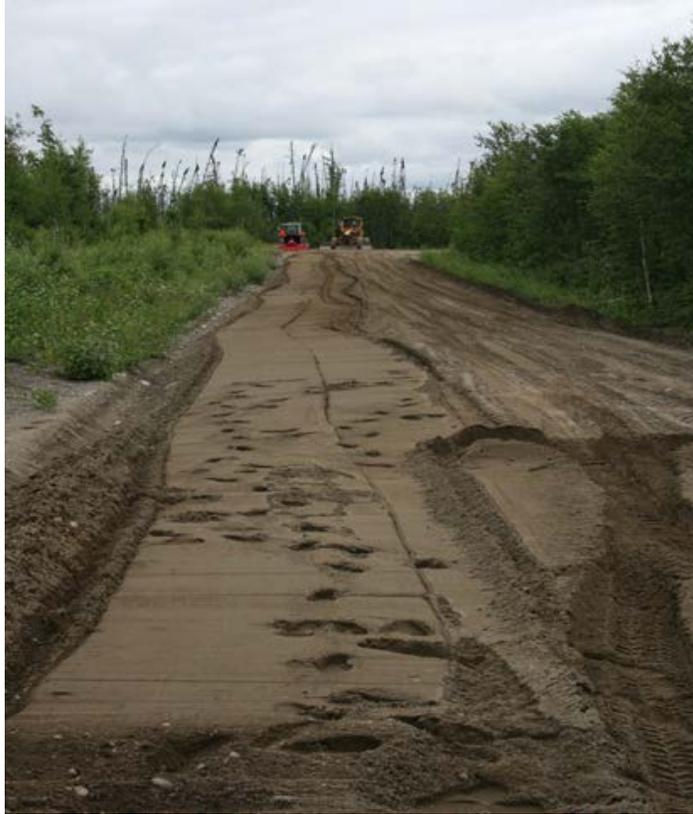
Figure 11: Roadway after being "fluffed"

Prior to construction, the road was “fluffed” using a rototiller (see [Figure 11](#)). “Fluffing” helps reduce density in the road soils before treatment, which aids in better distribution of the geofibers and Soil-Sement. The fluffing process involves simply running the rototiller over the surface of the test site in situ.

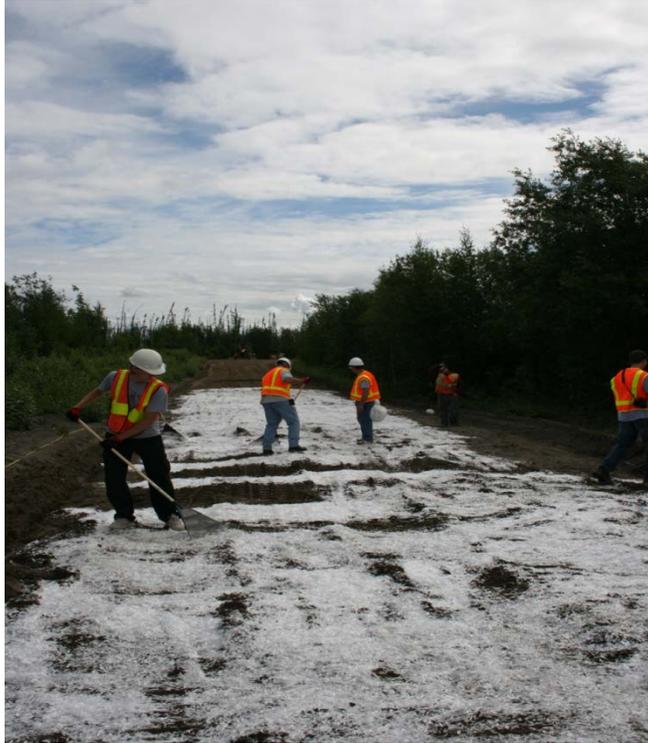
Figure 12: Achieving uniform application of fibers

In order to approximate the correct dosage rate, workers emptied each 30lb bag of geofibers at 8 foot intervals. The actual mixture reached was 0.4% geofibers by dry weight of the soil, which is slightly lower than the laboratory-observed optimum fiber point. Because the weight of fiber delivered to the project was lower than expected, the amount of geofiber was reduced in order to get a uniform distribution of fiber. The fibers were placed and spread using a garden rake, as shown in [Figure 12](#).

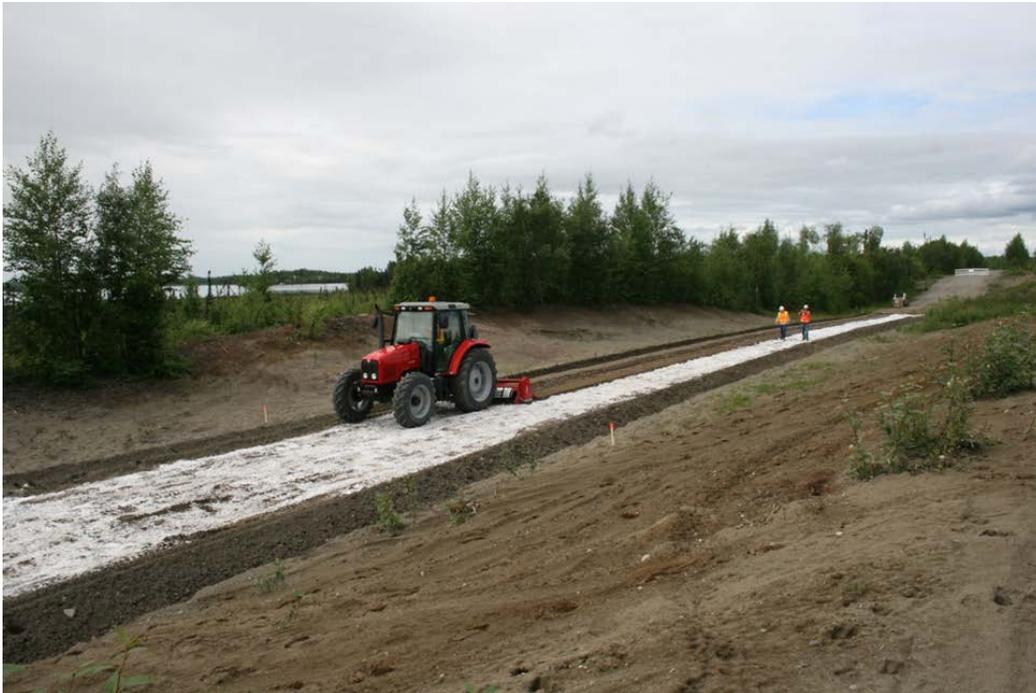
Figure 13: Rototilling geofibers

Once the fibers were placed evenly throughout the road bed, they were mixed into the sand using the rototiller (see [Figure 13](#)). The rototiller made several passes over the surface of the road until the fibers were thoroughly and evenly mixed throughout the test site.

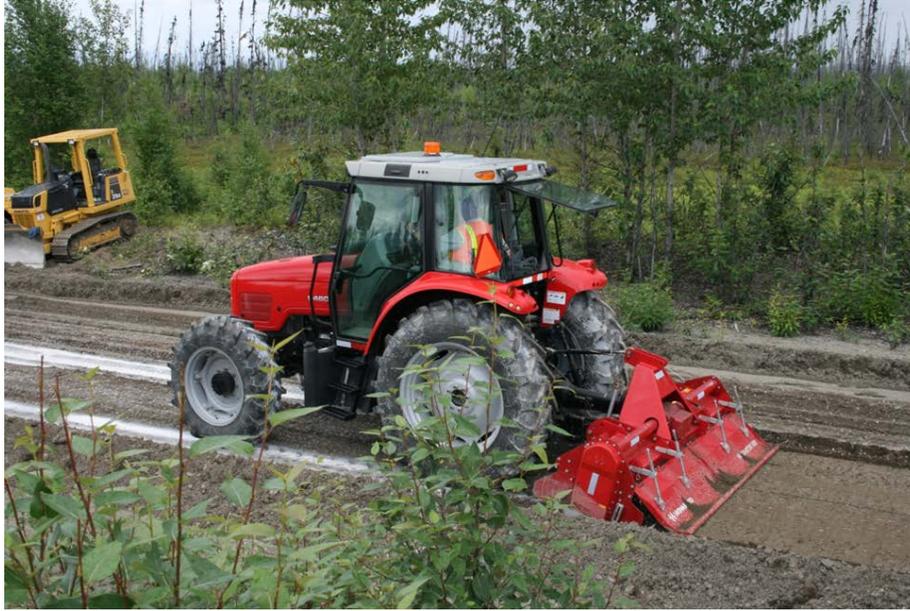
Figure 14: Final mixing of Soil-Sement and geofibers

Once the Soil-Sement was applied, the rototiller was used to thoroughly combine it with the geofibers and soil. The rototiller combining all the treatment materials is shown in [Figure 14](#). In this picture the noticeable pooling during Soil-Sement application is visible on the parallel tracks in front of the rototiller. After mixing, the road section was then cut and shaped using a grader (see [Figure 15](#)). Once the road was shaped and leveled it was compacted as shown in [Figure 16](#).

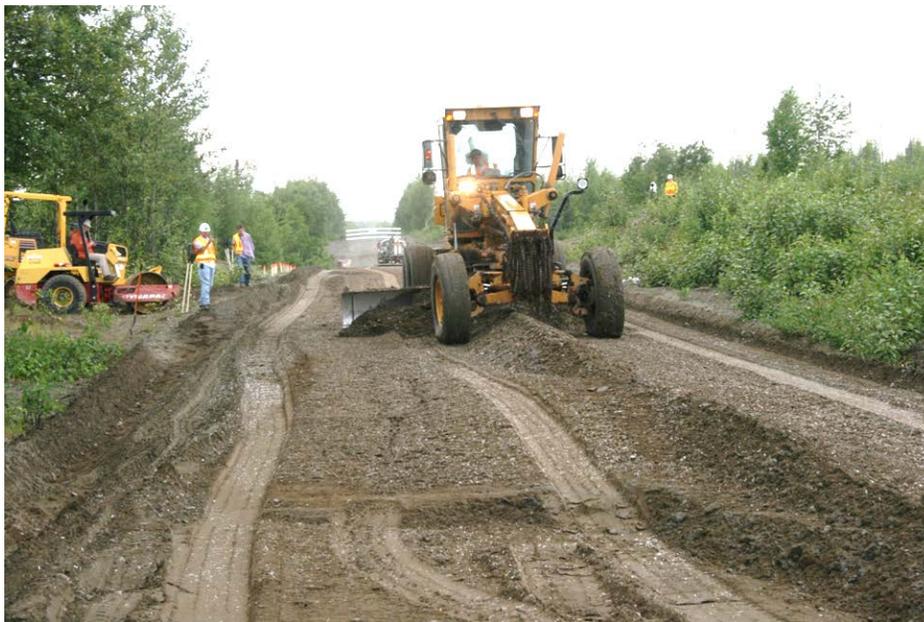
Figure 15: Shaping and grading

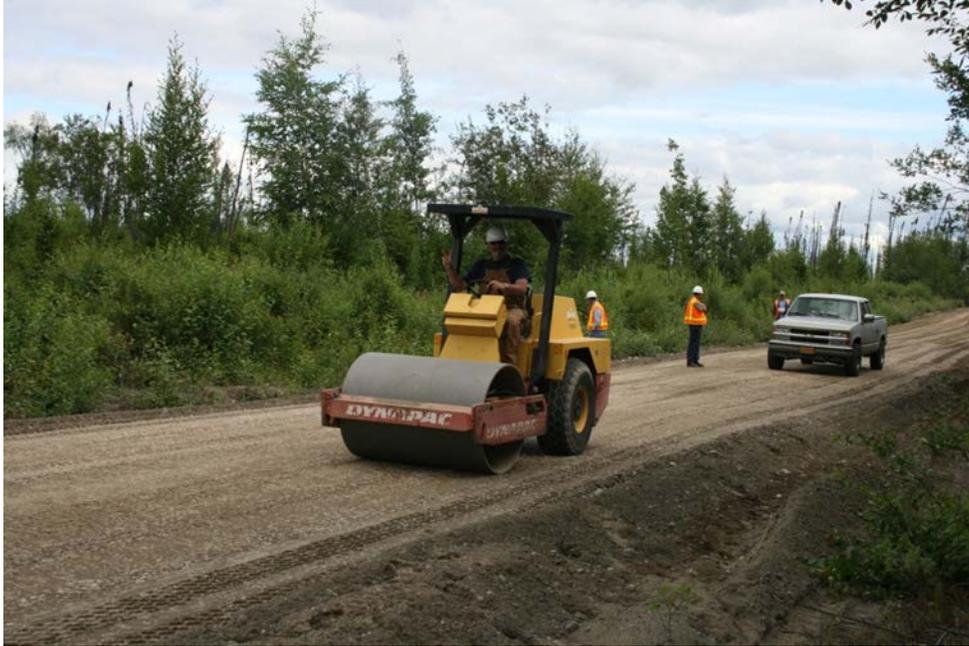
Figure 16: Compacting roadway

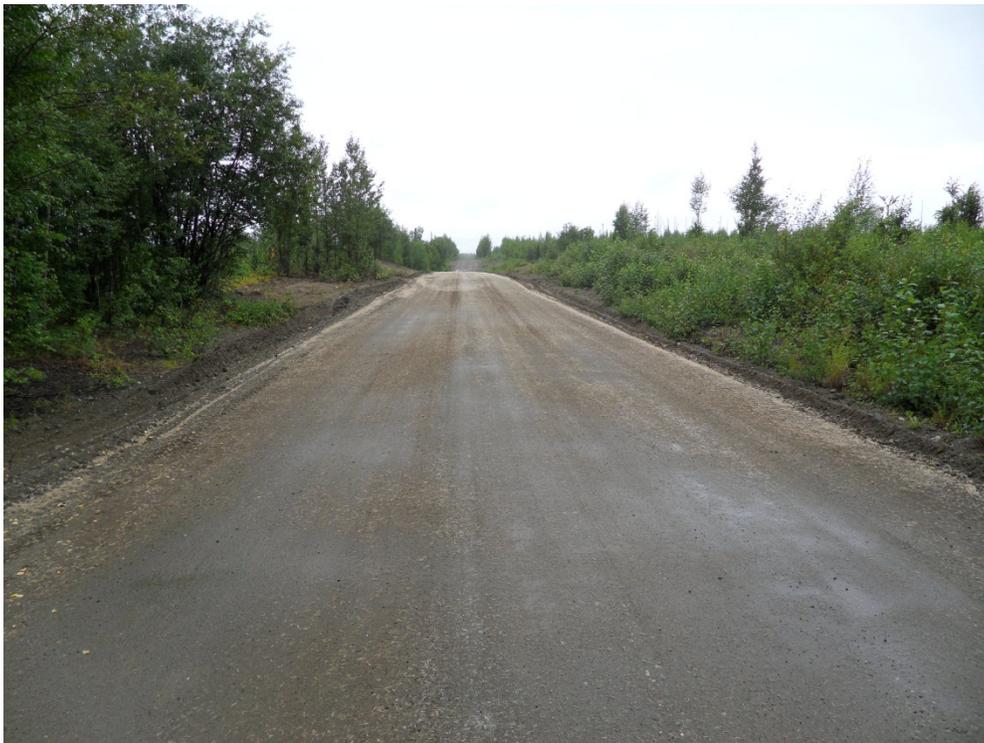
Figure 17: Completed roadway

Once thorough mixing was finished and the road was compacted a final application of Soil-Sement was used to seal the top layer of the soil. The sealant application was composed of 1450 gallons of Soil-Sement mixed with a small amount of water. The Soil-Sement sealant keeps the surface fibers in place and provides a stiff surface on the road bed. The completed roadway is shown in [Figure 17](#).

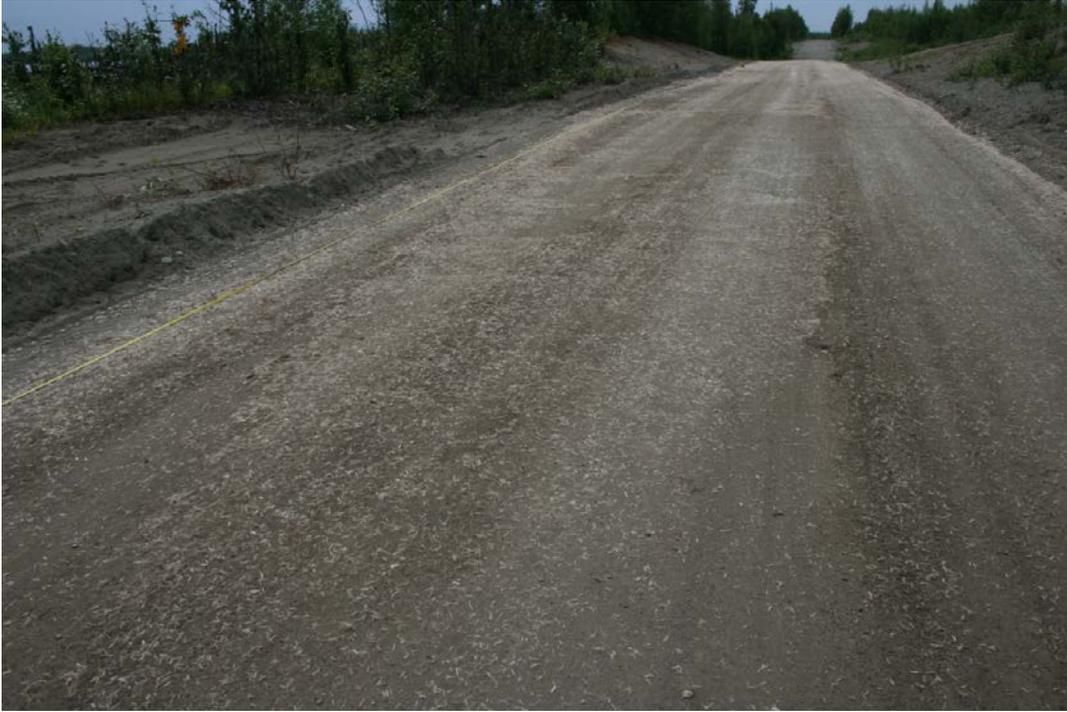
Figure 18: Roadway one week after construction

One week after the completion of the treatment, stiffness measurements were taken were taken again at 25 foot intervals. To visual observation, the test site appeared stiffer and the surface looked more abrasion-resistant than immediately after construction; [Figure 18](#) shows the road a week after construction. The average CBR value in the center of the road is 22, an improvement of 340%. The CBR values on the sides of the road also increased, with values of 17 and 18, on the tree and lake sides respectively. The CBR values obtained throughout the road one week (August 7th) after treatment are presented in [Table 4](#).

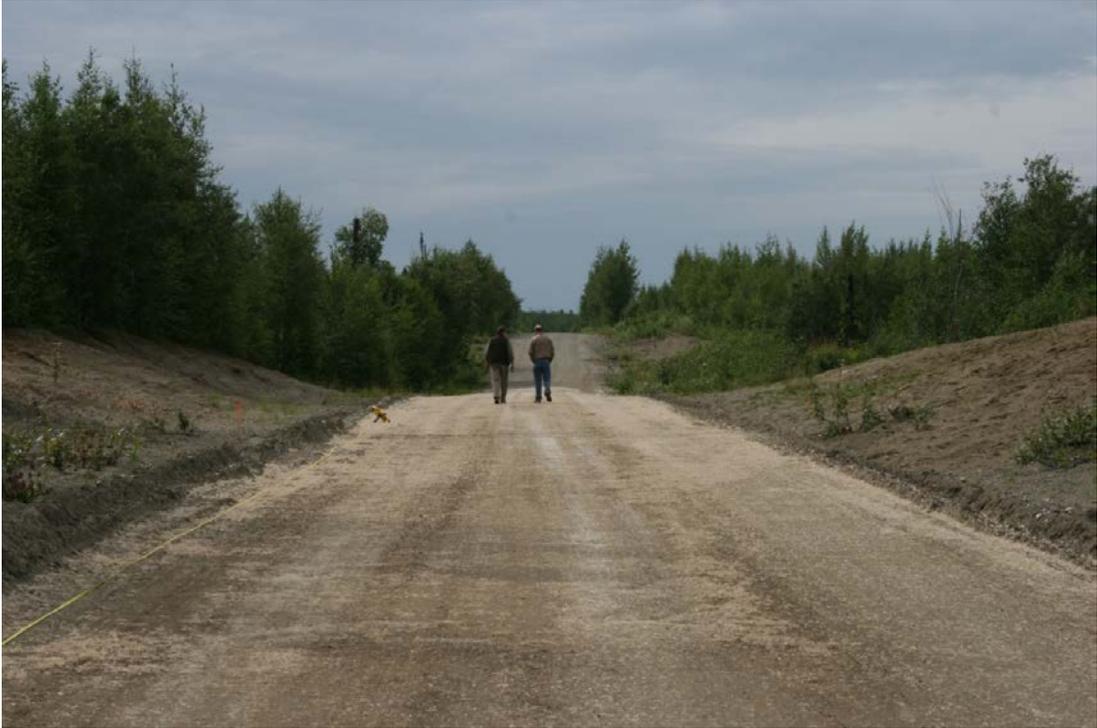
Figure 19: Roadway three weeks after construction (August 28th, 2010)

Some initial visual observations noted that some fibers had collected on the surface of the road near the center; this redistribution was most likely due to the wind from passing vehicles picking up the surface fibers and redepositing them. The fibers in the center of the road are visible in [Figure 19](#). It is evident that at the front of the road (photo foreground) there are fewer fibers on the surface, but closer to where the people are standing it is clear there are significantly more fibers in this area.

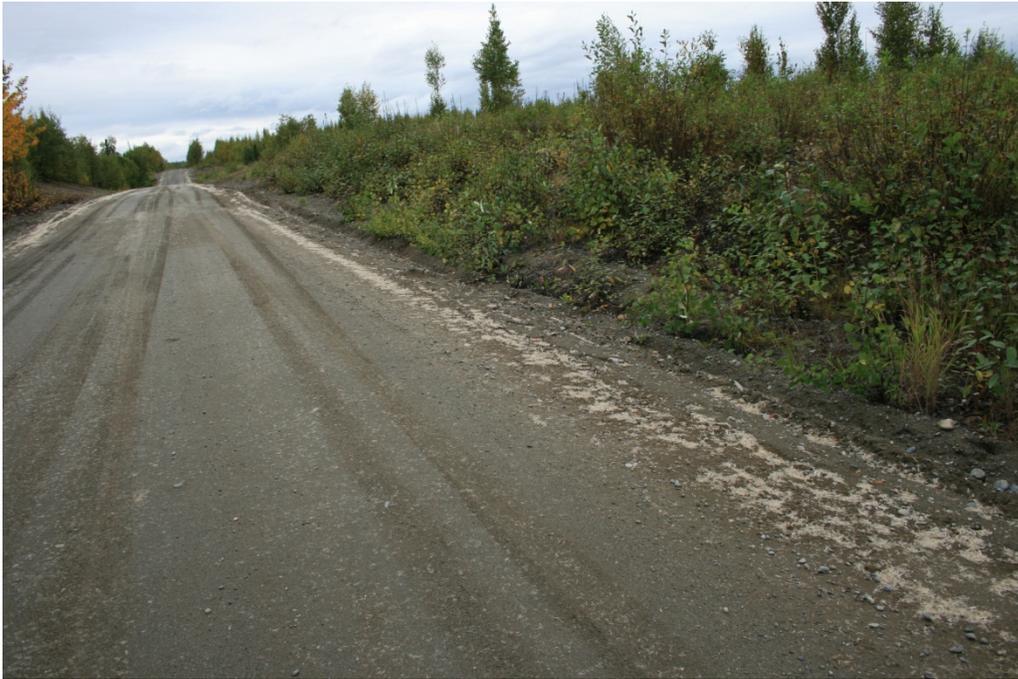
Figure 20: Test section September 7, 2010

was no degradation of the surface or soil strength over the winter, a major concern in cold climates. Indeed, the surface looked exactly the same as the previous fall as shown in [Figure 20](#).

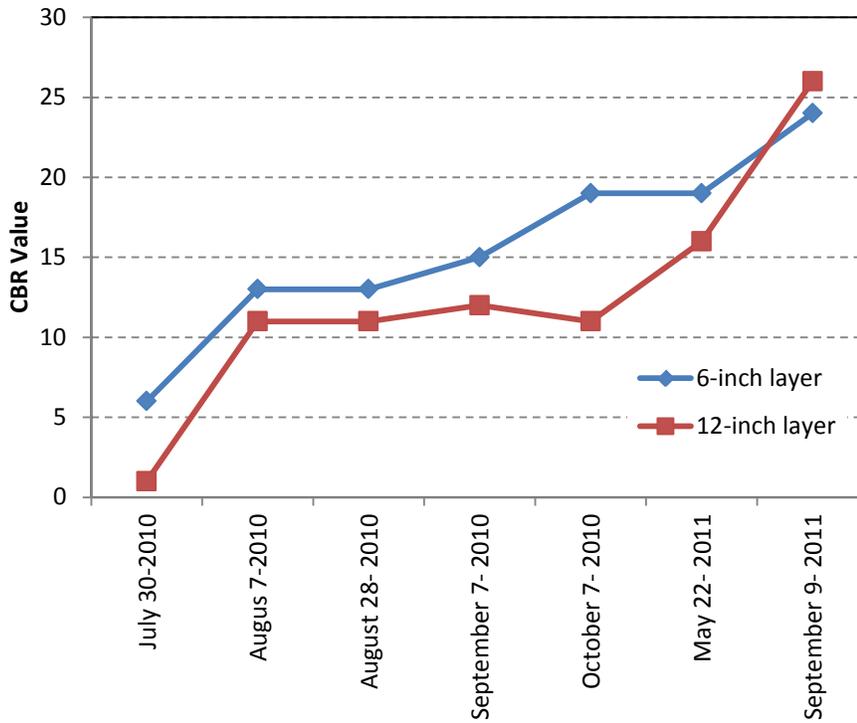
Figure 21: CBR over time

Figure 21 shows the average of CBR values over time for both the 6 inch and 12 inch test sections. Both sections show a steady increase in strength over time. However, the 12 inch section has lower CBR values until the September 9 measurements. This is likely due to inadequate compaction effort on the 12 inch section.
