TIRE CHAIN DAMAGE ON BRIDGE DECK WEARING SURFACES

A Project Submitted in Partial Fulfillment of the Requirements

Civil Engineering

University of Alaska Fairbanks

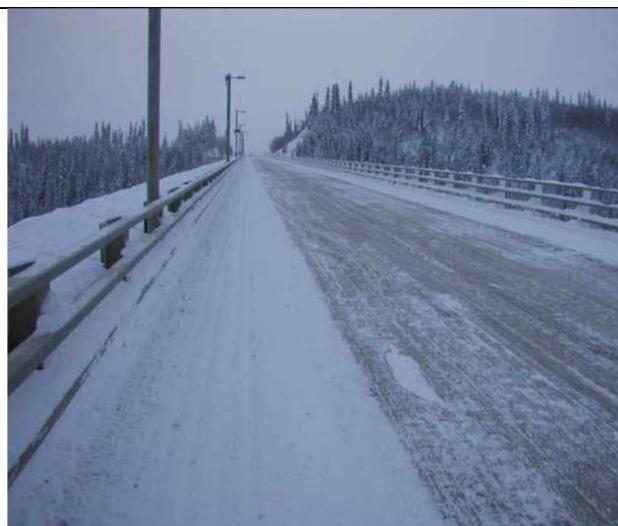
Figure 2. Yukon River Bridge in Winter

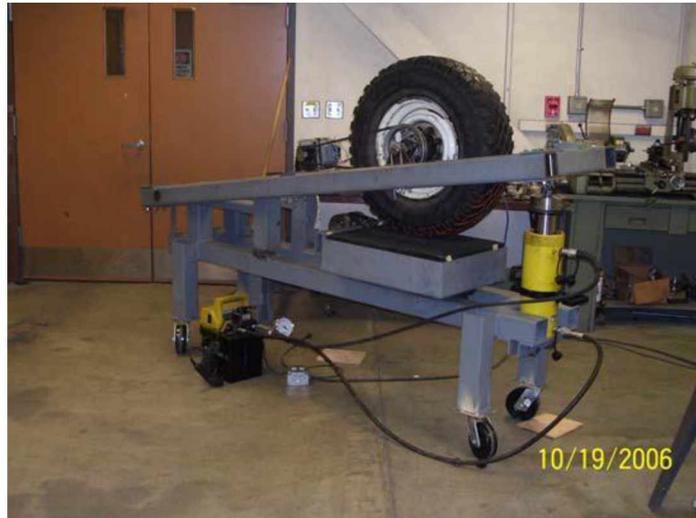
Figure 3. Traction Equipment

Tire chains on heavy trucks are considered to be a major source of damage to the Yukon River Bridge deck wearing surface. Since no known laboratory test could be found to determine wear due to tire chains, test equipment and a testing procedure was developed. The testing apparatus consists of a tray which contains the sample to be tested; this tray may be moved horizontally over a distance of 20 cm by use of a hydraulic ram. Located over the sample tray is a 14 ply 235/85R16 tire through which downward force may be applied to the sample by means of a

second hydraulic ram. The tire is located on an axle and that may be allowed to rotate in the direction of motion of the sample, or locked depending on the requirements of a given test. Electric load cells are provided to measure vertical and horizontal force on the tire in the direction of motion of the sample. Test samples maybe up to 45 cm wide by 61 cm long by 15 cm thick. The entire apparatus is approximately 60 cm wide 230 cm long and weighs around 4500 N. The small size is required to fit within the low temperature testing room available, see Figure 3.

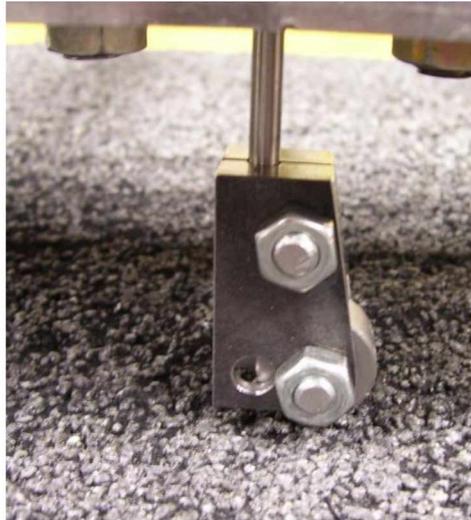
Figure 5. Profile meter disk on Transonite panel

4.1.4 Lessons Learned - Wear measurements are taken by profiling the surface before and after testing. The surface of the panel is in contact with a disk 19.05 mm in diameter and 9.53 mm wide. The position of the disk is recorded in the horizontal and vertical directions as it is moved over the panel in the long direction of the panel. Values listed are for the largest change in surface as recorded by the profiler. Rolling tests failed to show significant damage in rolling tests. This was due to the tendency of the tire chains to cause highly local damage to the panel in the form of depressions about 8mm in diameter. The chains then returned to these damaged locations on subsequent cycles of the test. This resulted in the panels' depressions forming to the shape of the chain, resulting in little increase in damage on subsequent cycles. The profile disk will not enter these small depressions, see figure 5.

The rolling testing procedure will be adjusted to address this problem. Panels will now be measured at random locations with a depth gage to find an average surface depression depth. The tire will then be rolled over the panel and the depth of local damage measured. The increase in depth of the damaged minus the average depression depth will be counted as the depth of damage. Currently no results are available for this new testing procedure.
